CHA # 30855

**Wee Wah Lake & Pond No. 3  
Dam Rehabilitation Project  
Village of Tuxedo Park, New York**

August 25, 2017

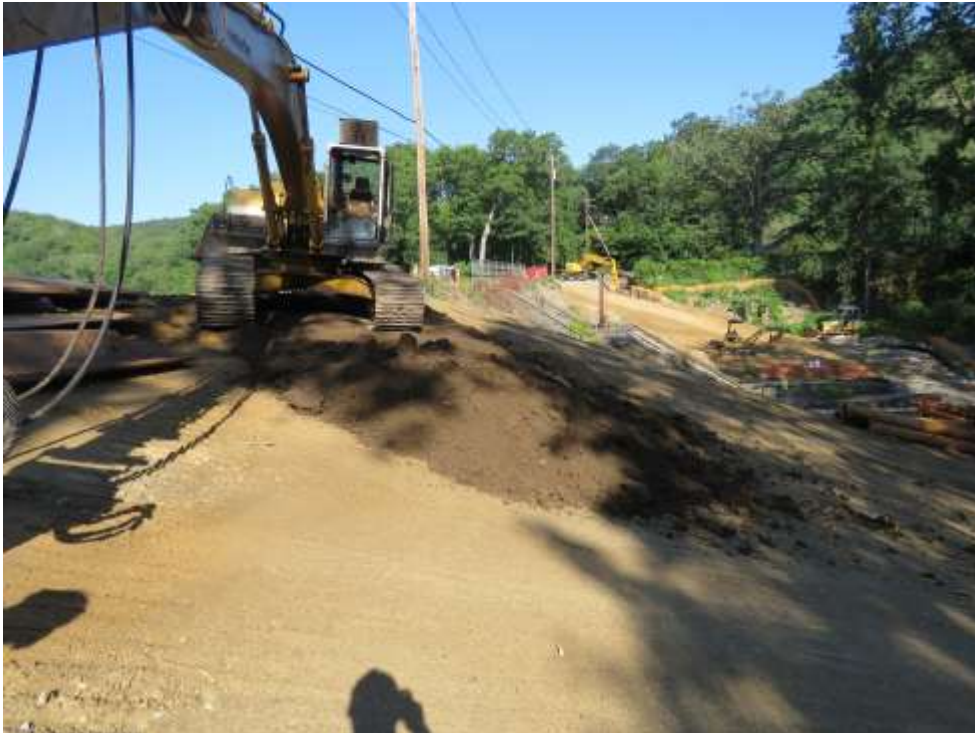
1

Right Side of Downstream Embankment Slope with Topsoil being stockpiled. Pipes shown (right side of photograph) are abandoned pipes removed from the service spillway discharge channel.

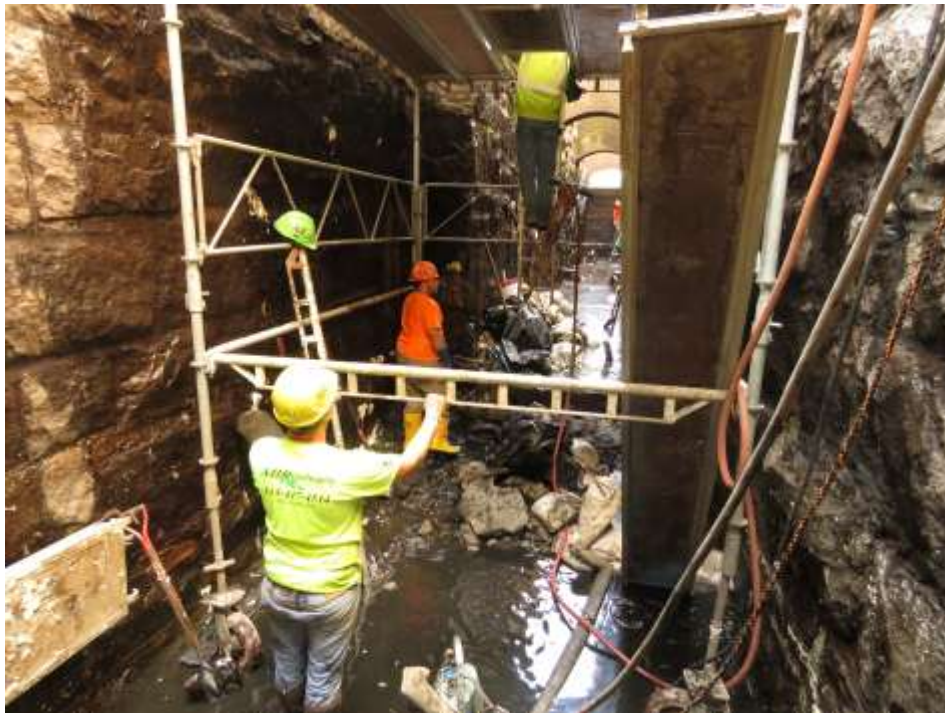
2

Debris Removal of Service Spillway Sump and 5.5' wide channel.

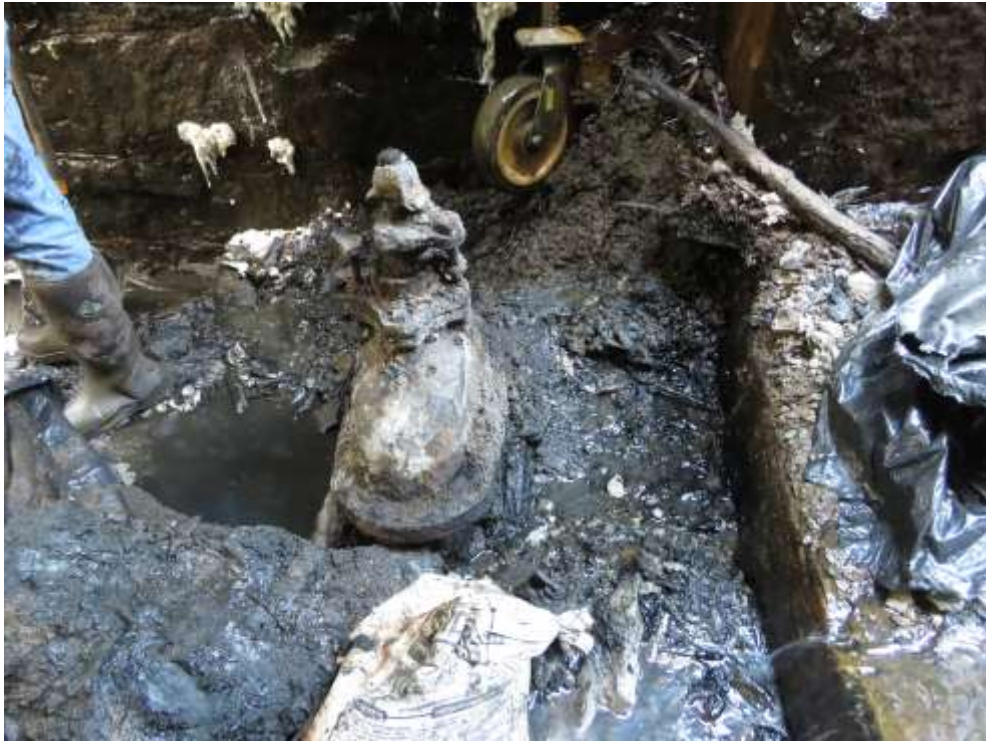
3

Outlet Valve within Service Spillway Sump.

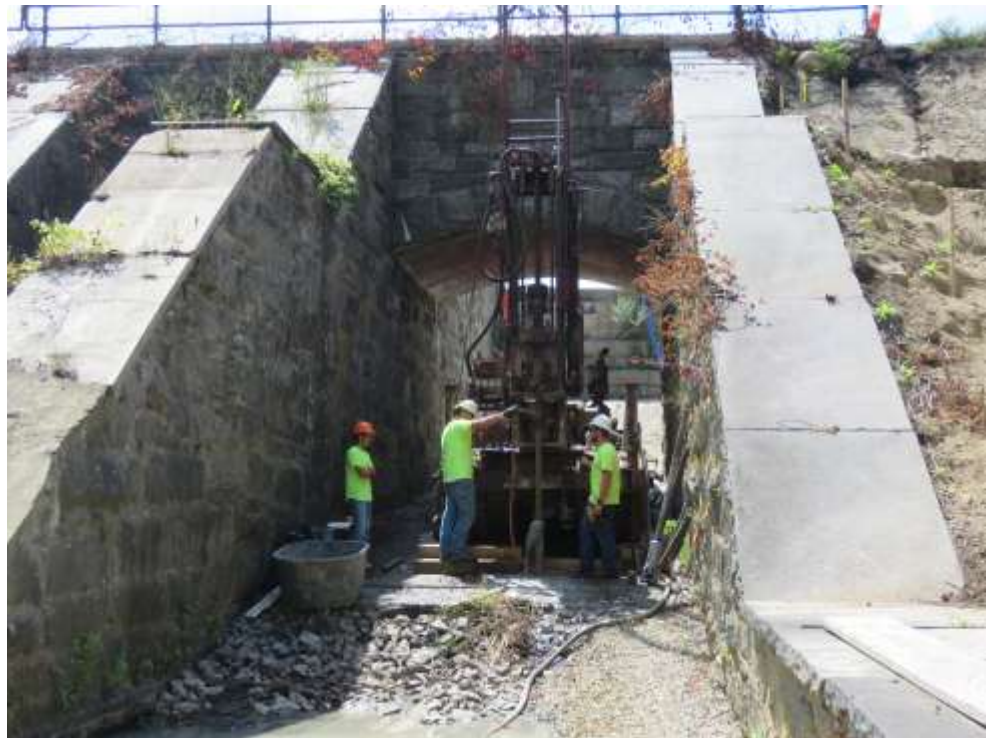
4

Looking Upstream in Auxiliary Spillway at drilling operations for VW-Piezometer Installation.

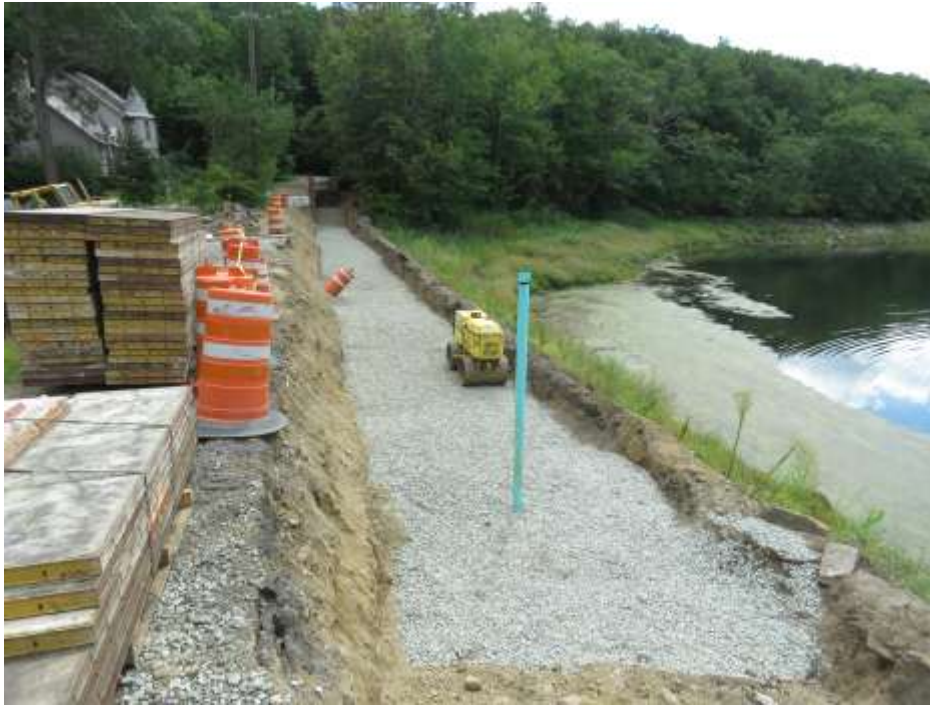
5

Parapet wall footing excavation. PVC pipe is casing of VW-Piezometer EM-5.

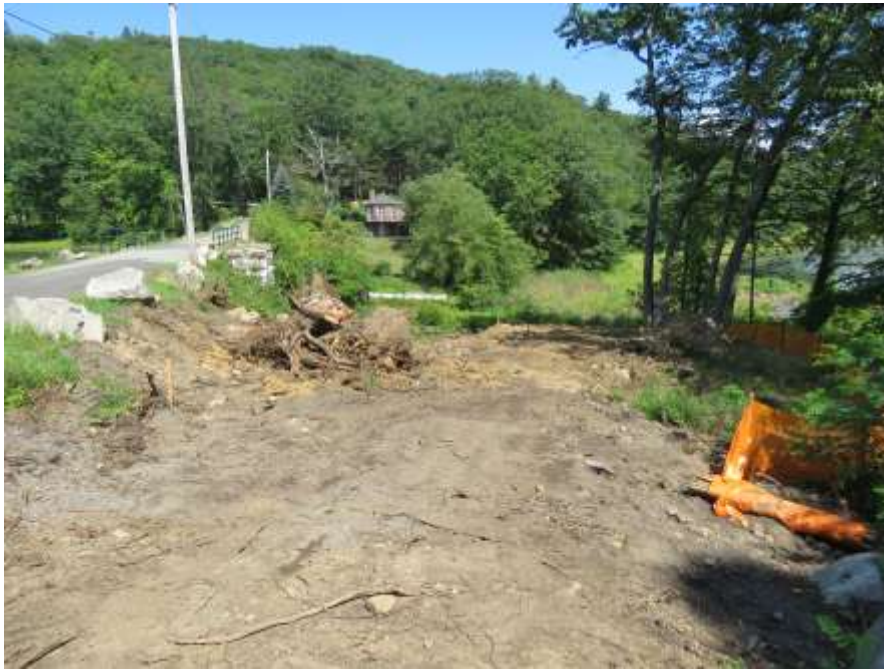
6

Pond No. 3 stump removal and clearing and grubbing of LLO siphon trench alignment.
