CHA # 30855

**Wee Wah Lake & Pond No. 3
Dam Rehabilitation Project
Village of Tuxedo Park, New York**

September 25, 2017

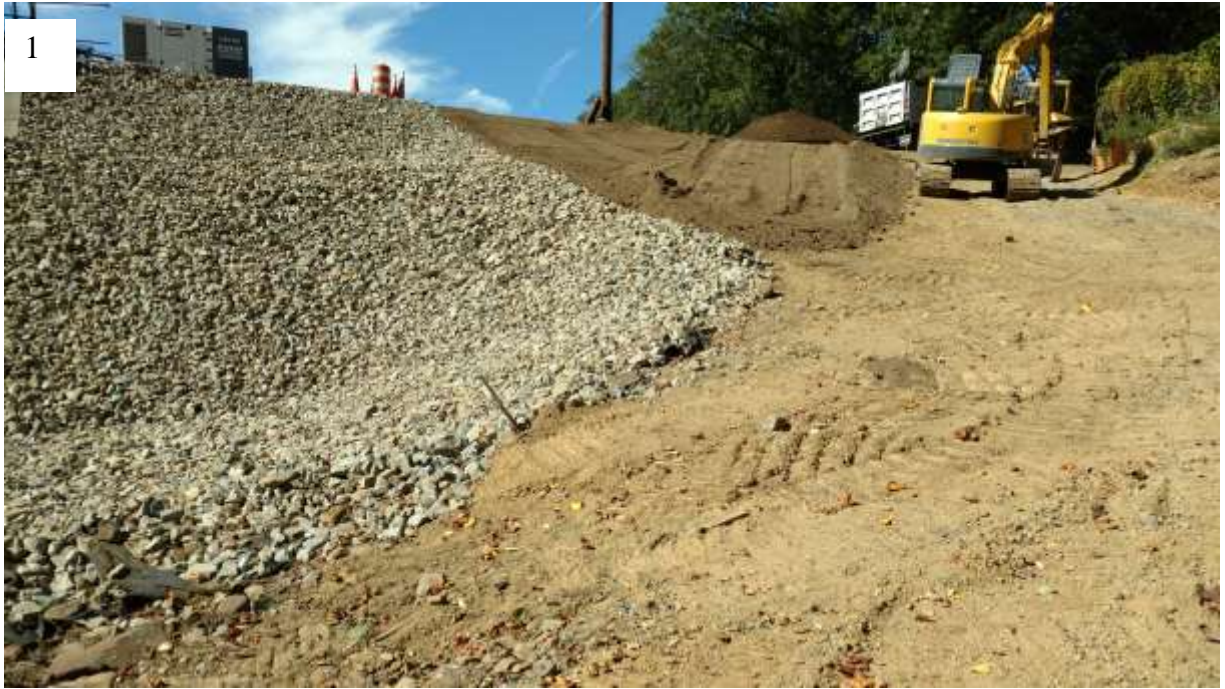
1

Left Side of Downstream Embankment Slope with Topsoil being place adjacent to rip rap slope protection placed to edge of service spillway discharge channel.

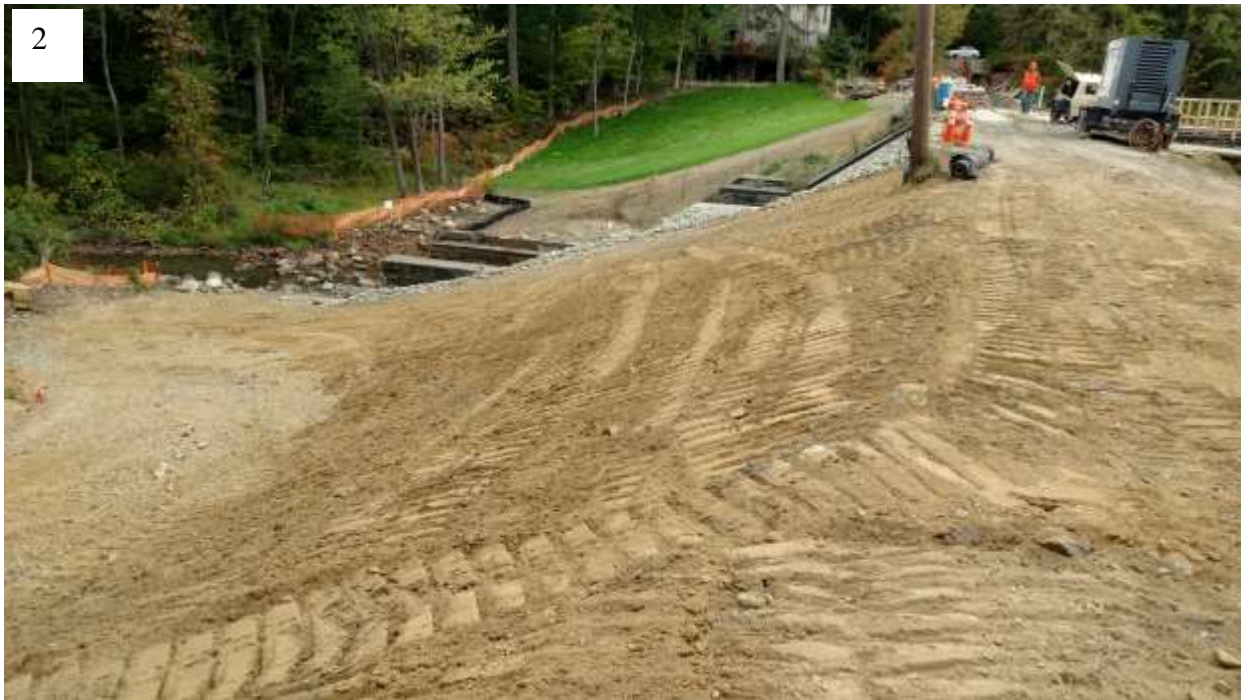
2

Completed left downstream slope grading prior to topsoil placement. Background shows completed embankment with temporary grass growth.

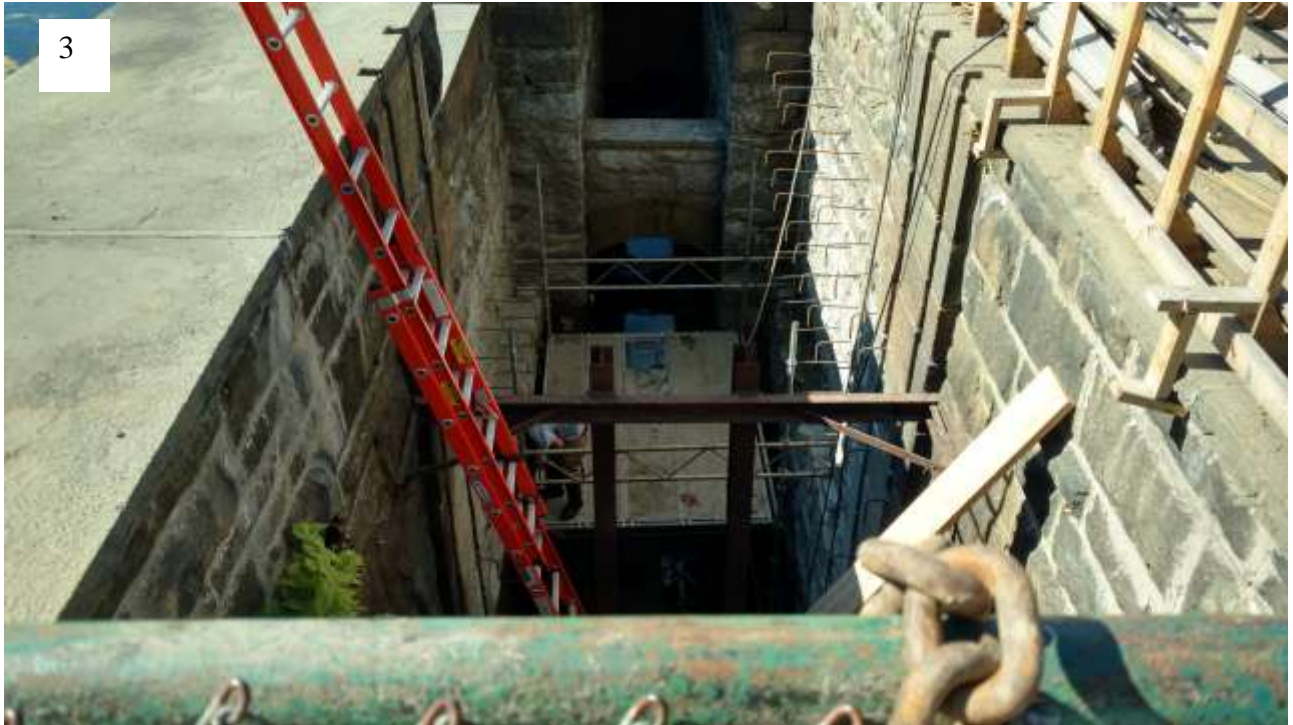
3

Service Spillway showing installation of grouted dowel hooks for overpour concrete wall construction.

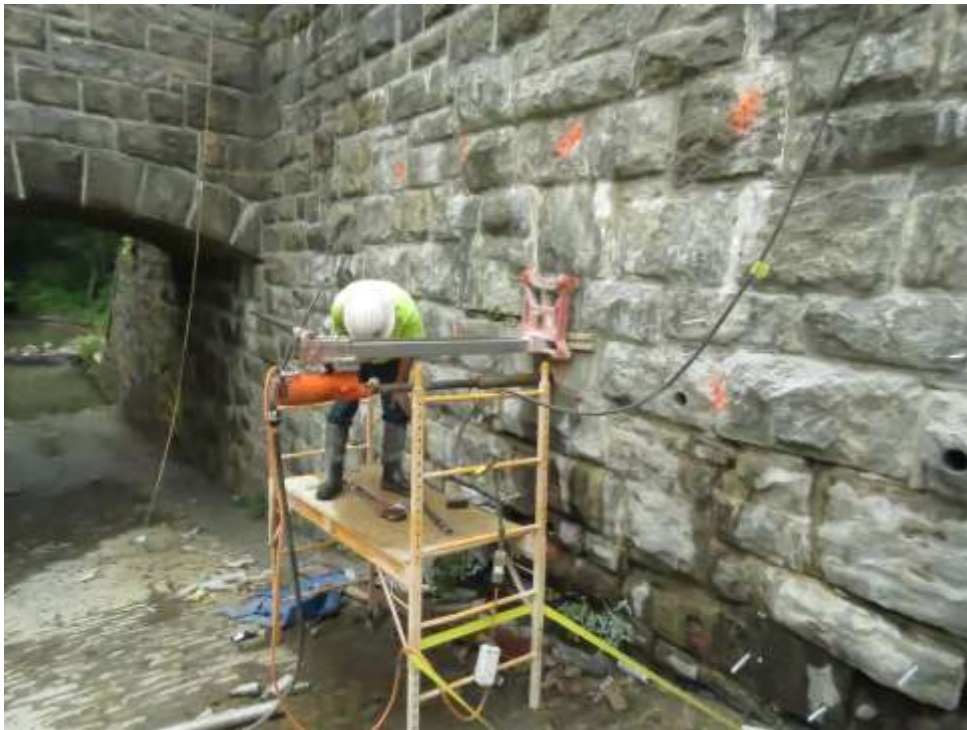
4

Coring operations in preparation of through bolt installations of the right auxiliary training wall.

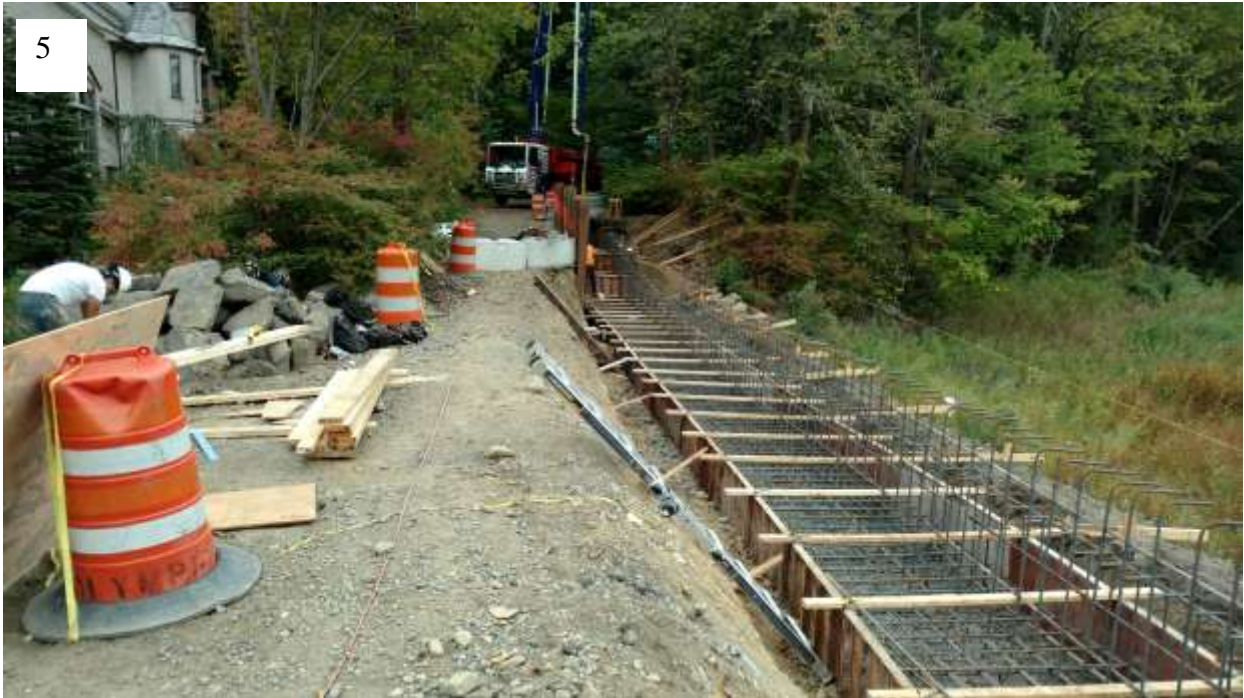
5

Start of parapet wall base construction. Note concrete pump truck at east end of the wall.

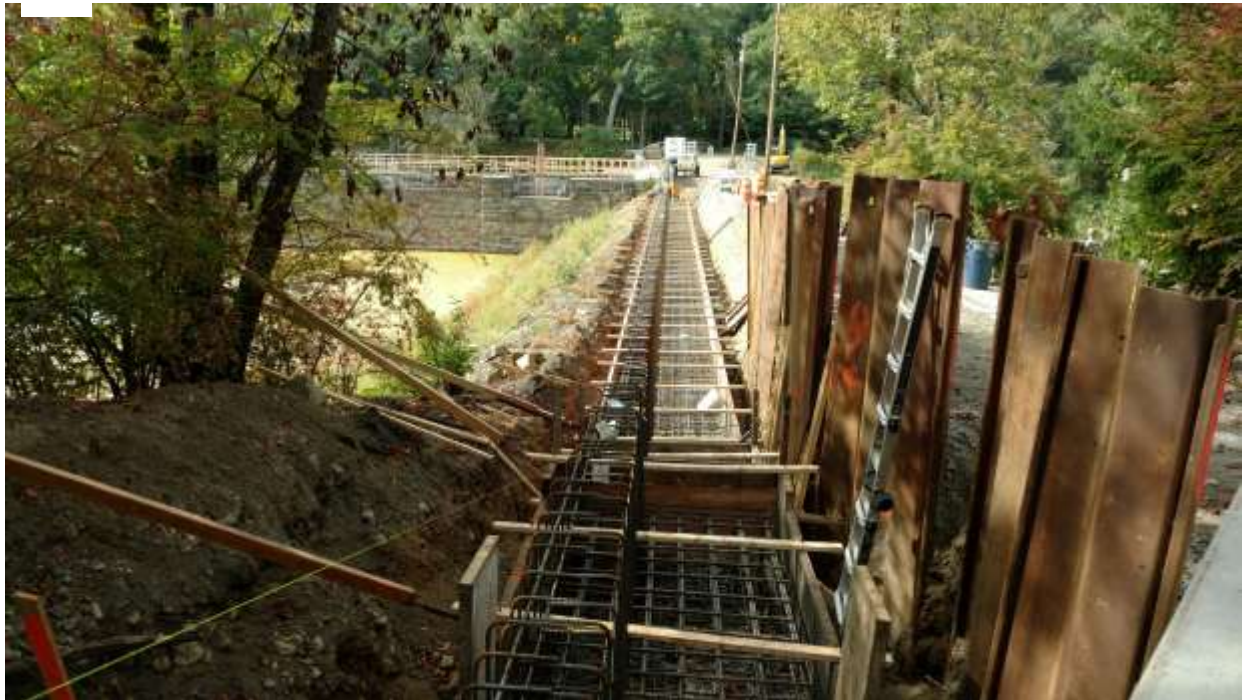
6

View of parapet wall segments E and D from right abutment of the dam just prior to concrete placement for base construction.
