CHA # 30855

**Wee Wah Lake & Pond No. 3
Dam Rehabilitation Project
Village of Tuxedo Park, New York**

November 27, 2017

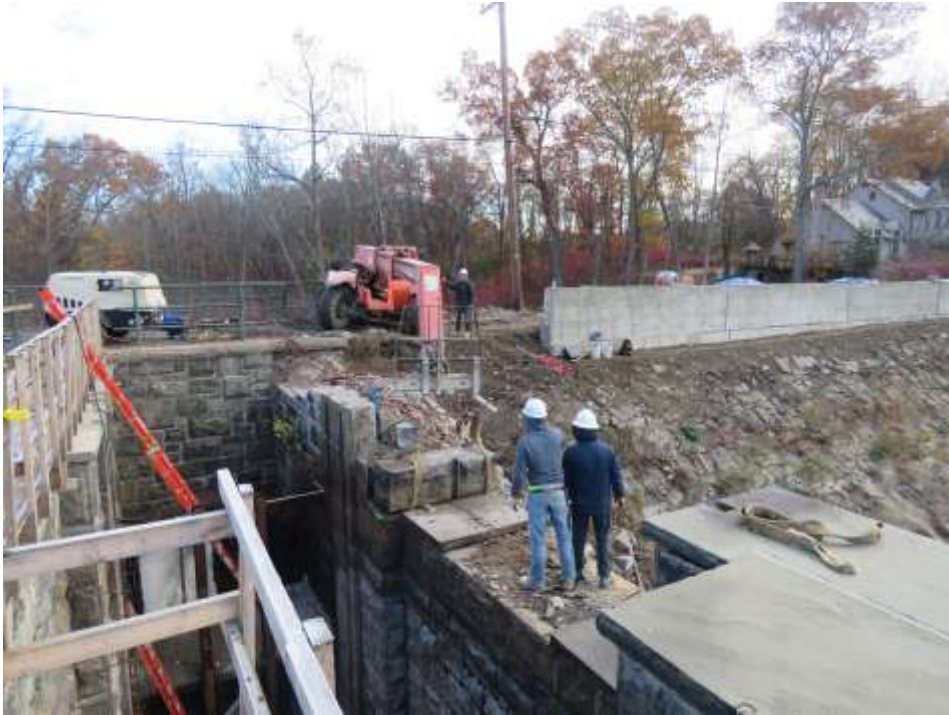
1

Primary Spillway, removal of existing stone masonry to expand spillway and construct forebay structure.

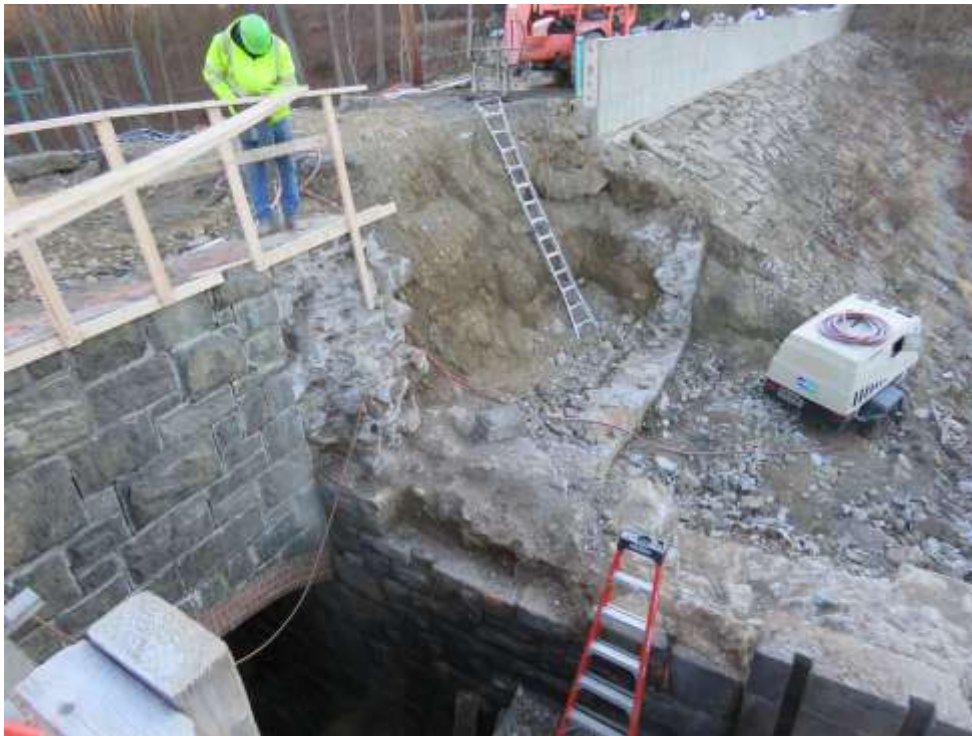
2

Forebay excavation and exposure of stone masonry cutoff wall (right side) within dam embankment.

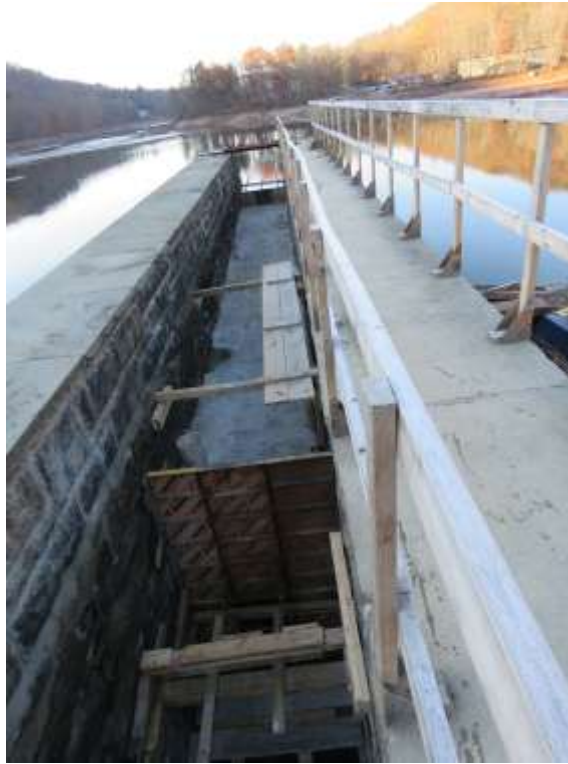
3

Service Spillway backfilled with mass concrete to elevation 491 ft.

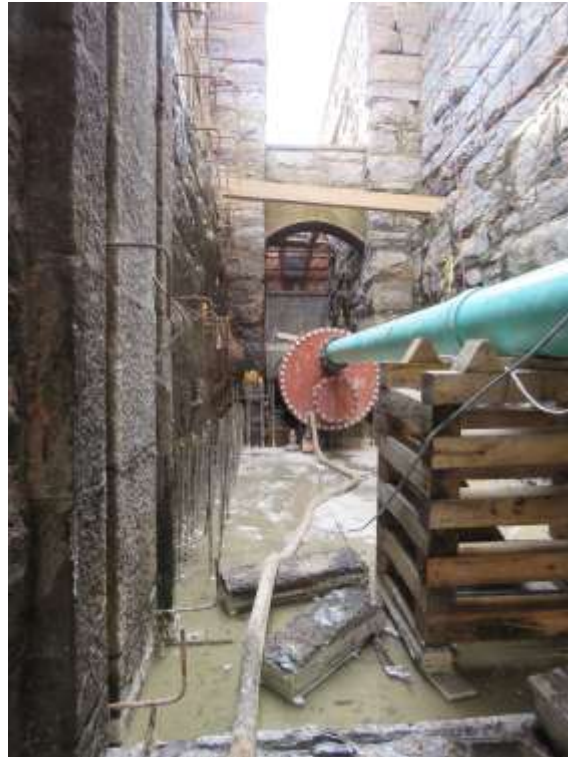
4

Construction of LLO within Service Spillway. Temporary PVC pipe used to convey base flow through construction area.

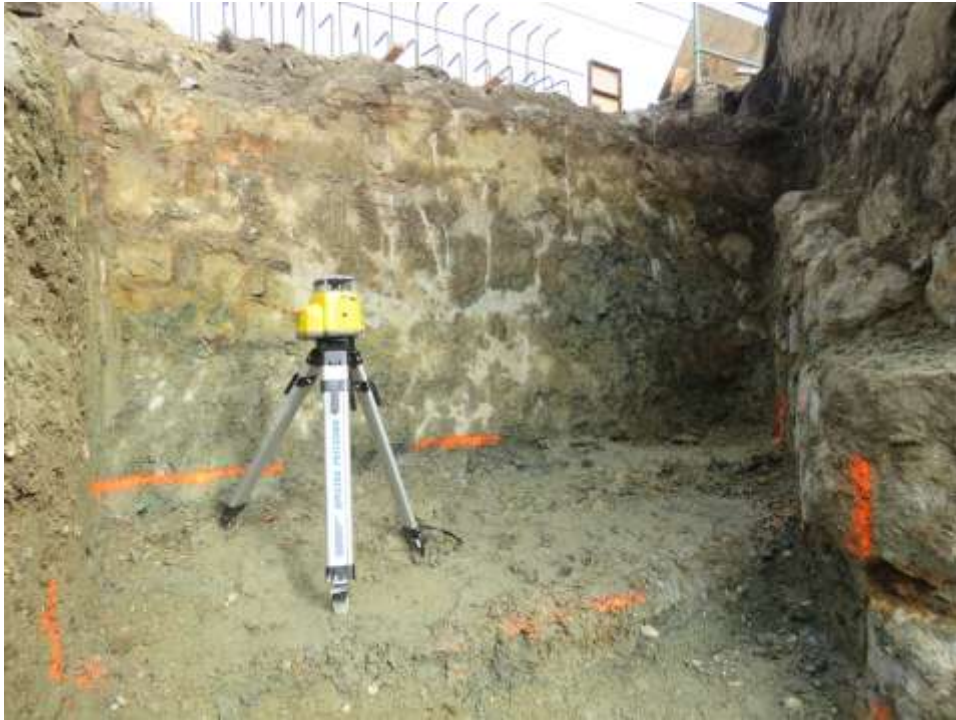
5

Excavation of re-entrant corner on left side of auxiliary spillway. Photo shows stone masonry corewall.

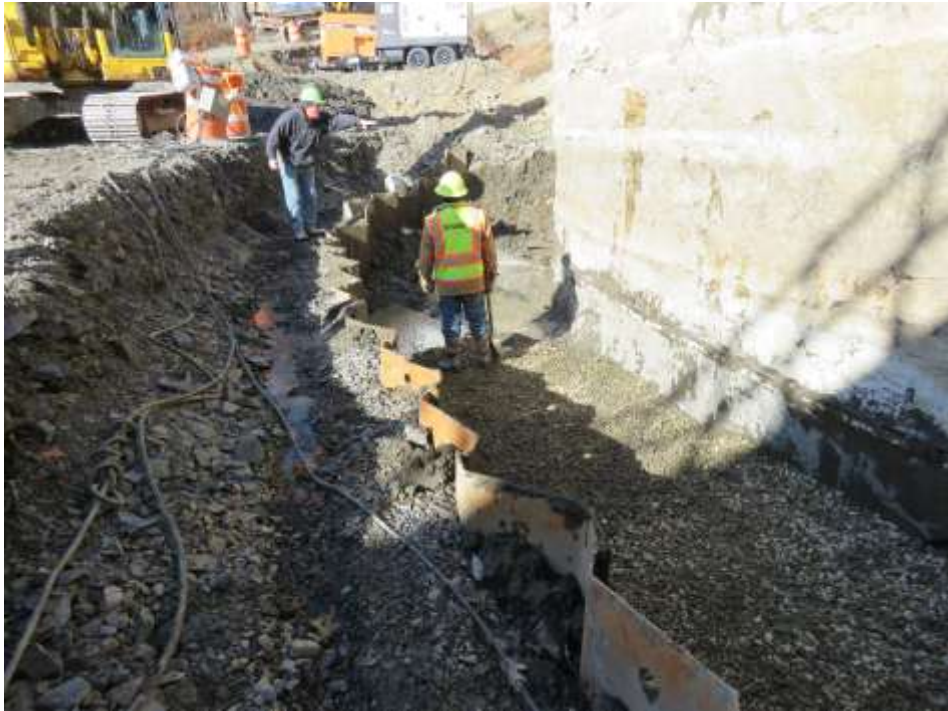
6

Sheet pile cutoff wall and excavation for auxiliary spillway overpour wall footing construction.

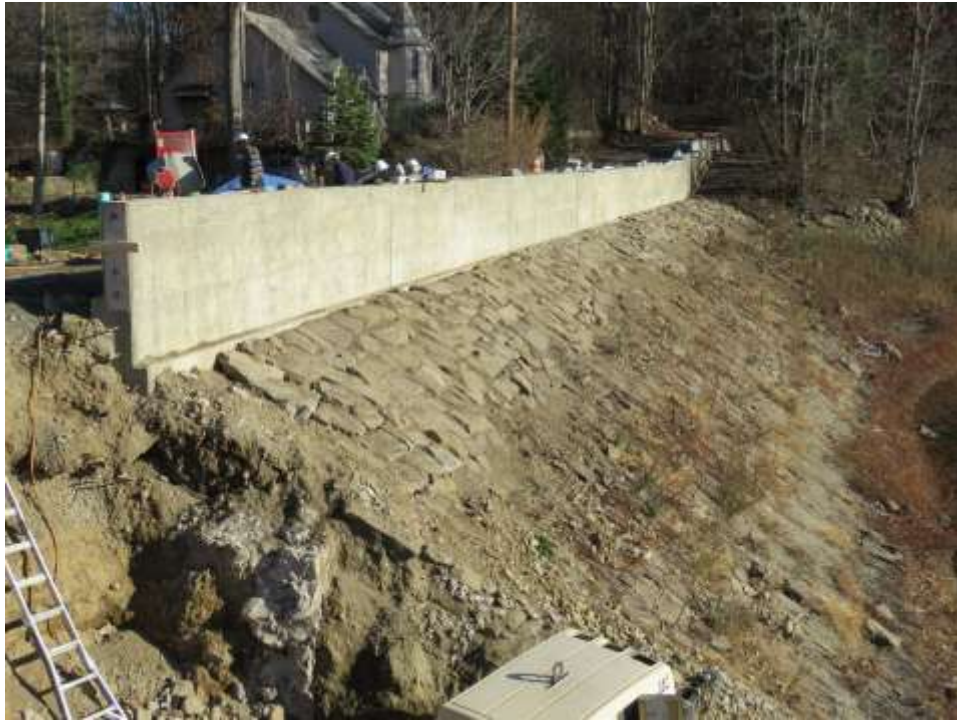
7

Completed armoring of u/s embankment slope along parapet wall Segments D and E.

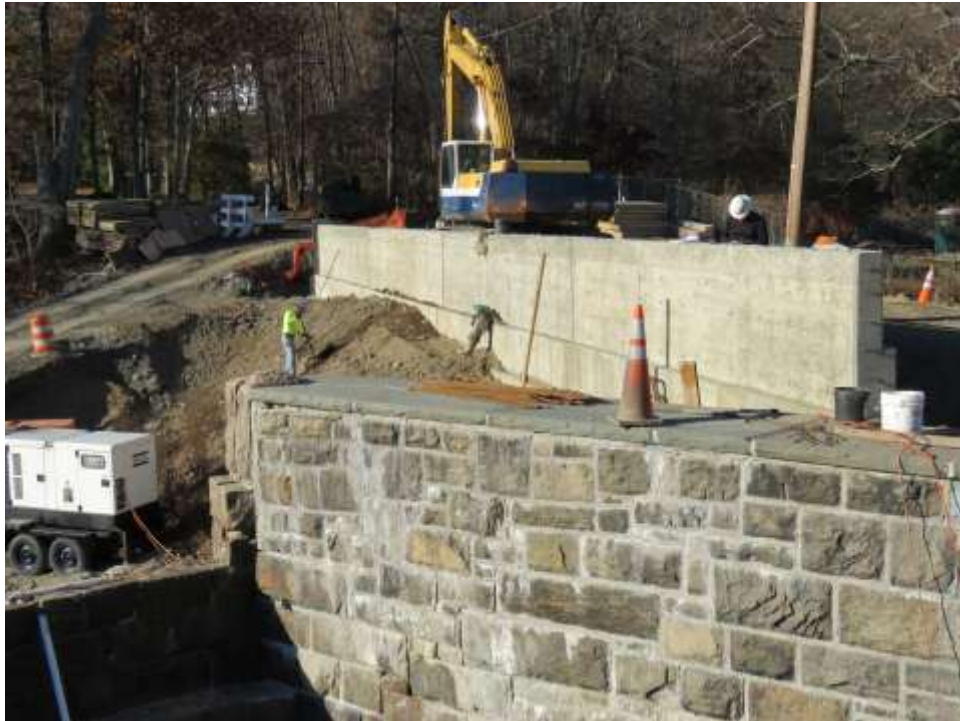
8

Construction of reinforced concrete parapet wall Segments B.

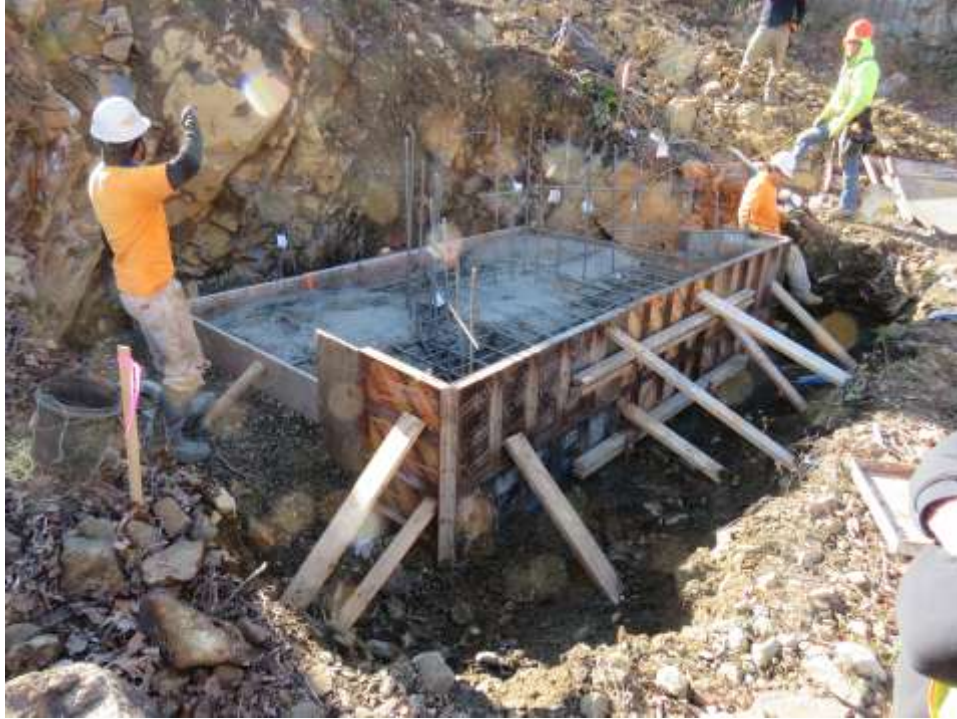
9.

Construction of footing for LLO siphon system discharge structure at Pond No. 3. Photo shows shallow bedrock present within the right abutment.

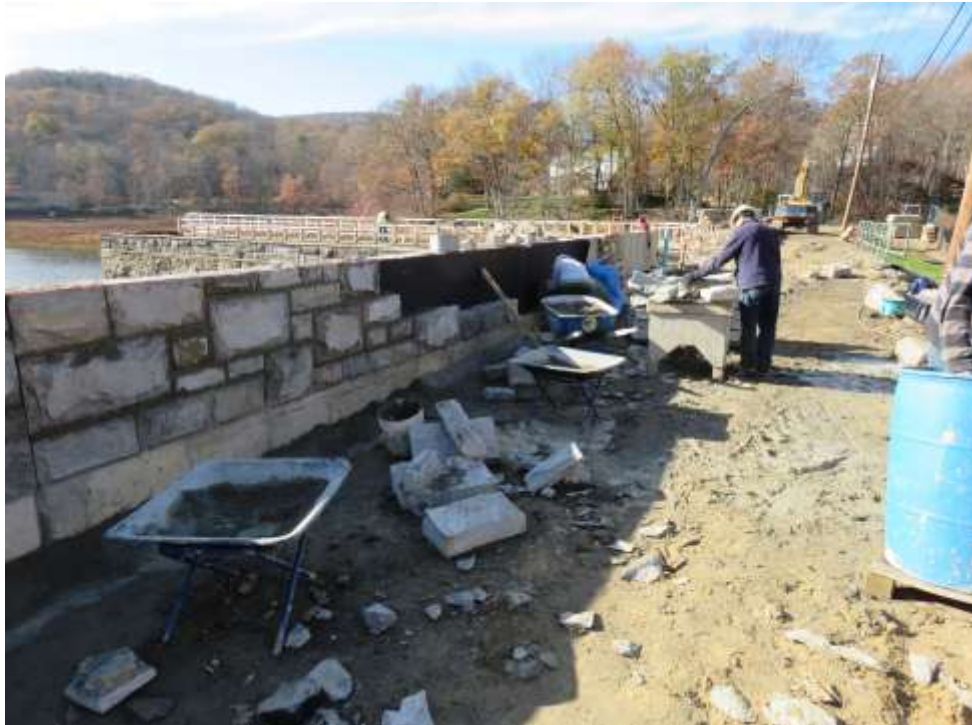
10

Reinforced concrete construction for Segment B of Parapet Wall.
