CHA # 30855

**Wee Wah Lake & Pond No. 3  
Dam Rehabilitation Project  
Village of Tuxedo Park, New York**

January 28, 2018

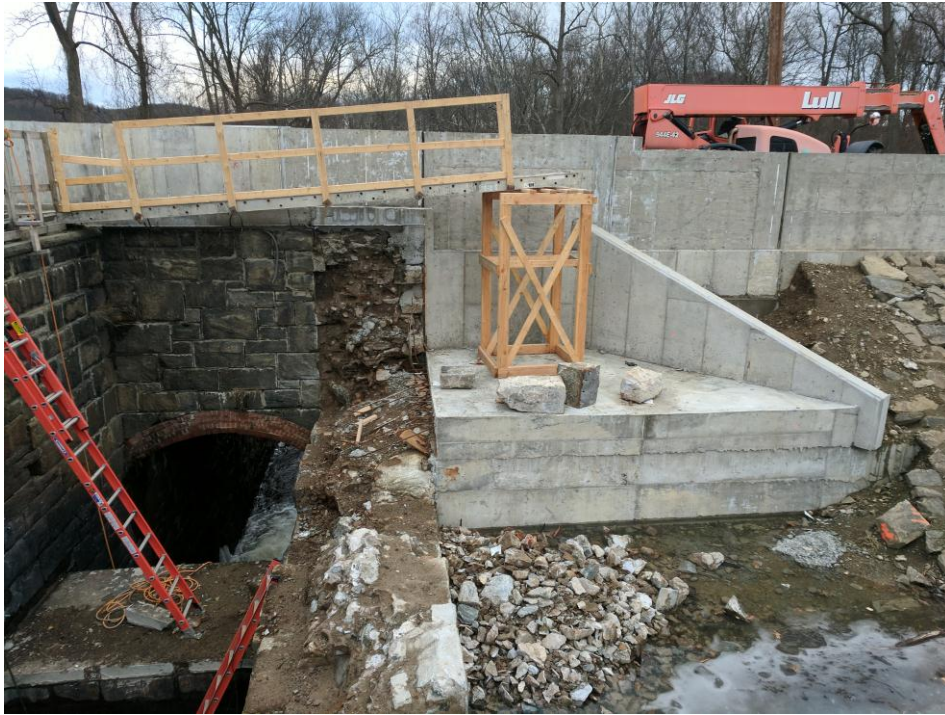
1

Completed construction of forebay structure for primary spillway and the integral segment of the parapet wall.

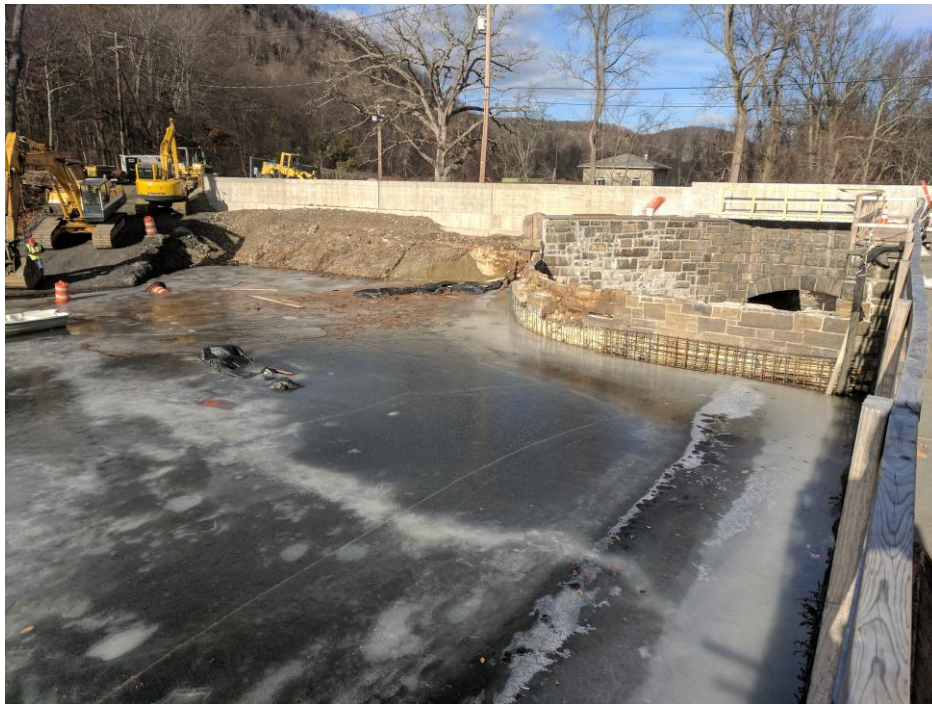
2

Completed reinforced concrete parapet wall with exception of Segment A on far left side.  
Photo also shows high construction water condition in front of Auxiliary spillway.

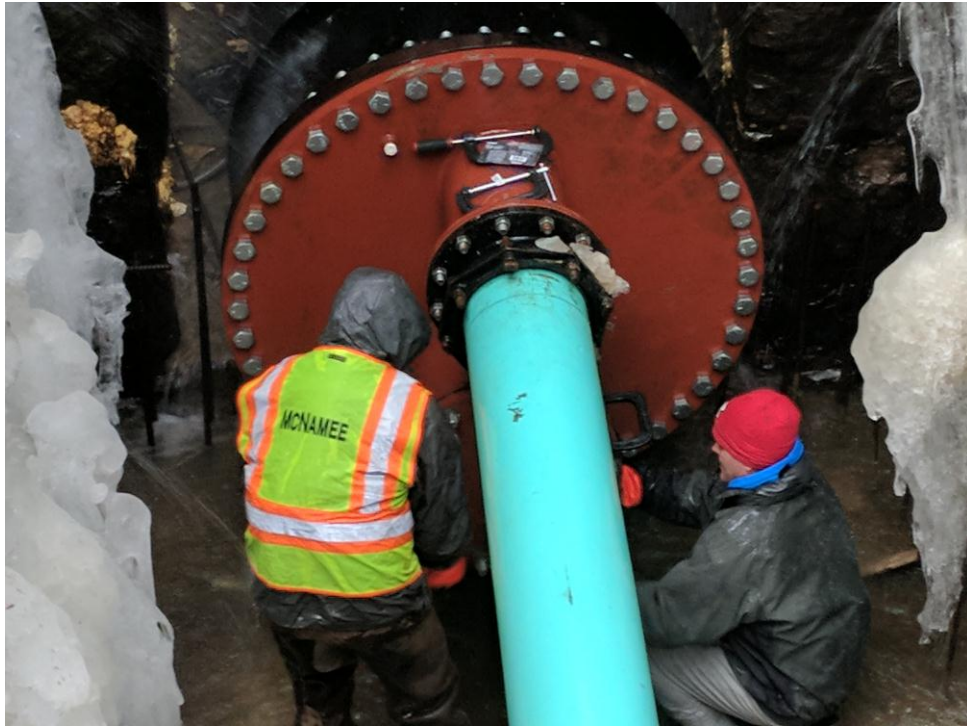
3

LLO pipe bulkhead with 12" dia. pipe connected and flowing full. Contractor working to open 18" dia. outlet.

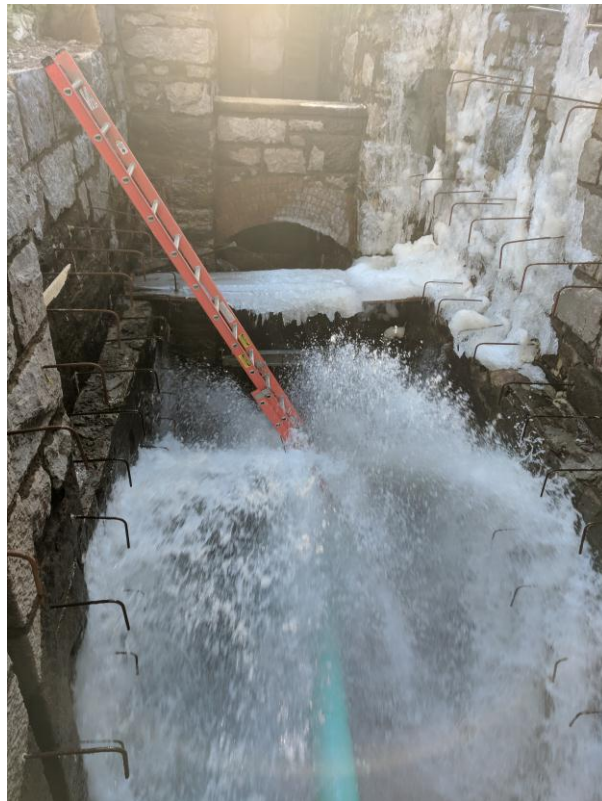
4

Flow after opening 18" dia. bulkhead penetration.

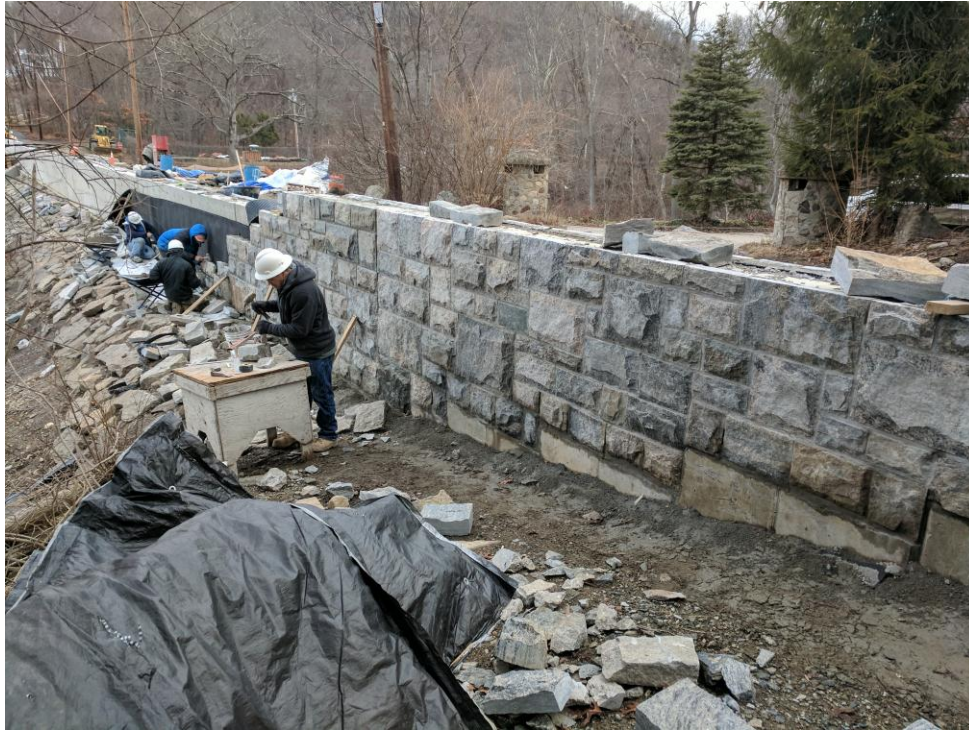
5

Parapet wall stone effacement construction on u/s face of Segment E.

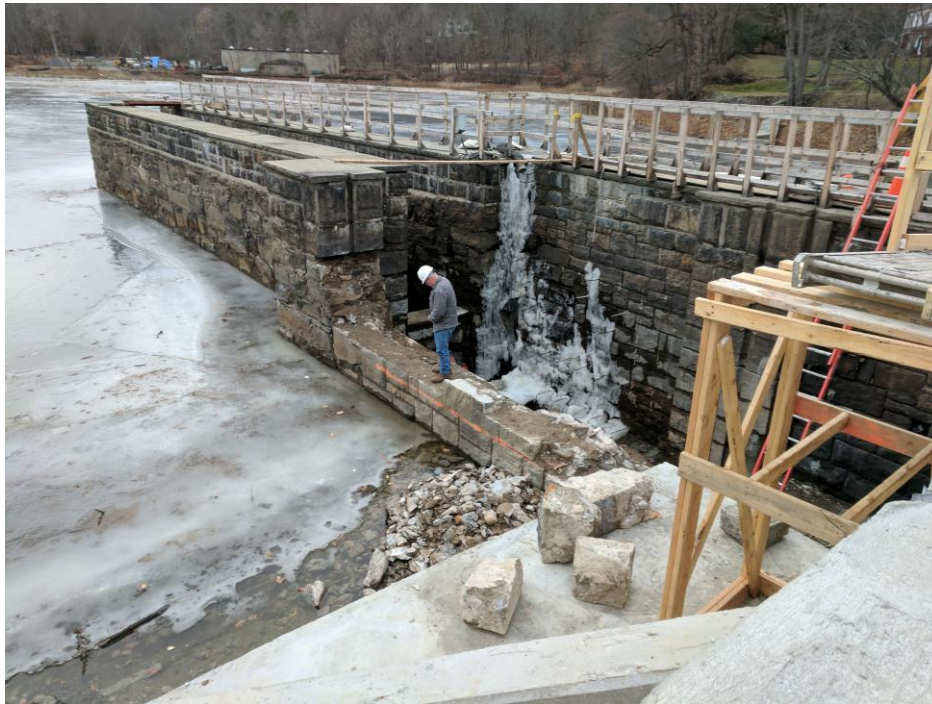
6

Primary spillway after stone/masonry removals to approximately elev. 487.5 ft. Temporary stone/masonry crest will be raised to elevation 492 ft. with the construction of a new reinforced concrete weir structure.
