CHA # 30855

**Wee Wah Lake & Pond No. 3  
Dam Rehabilitation Project  
Village of Tuxedo Park, New York**

July 24, 2017

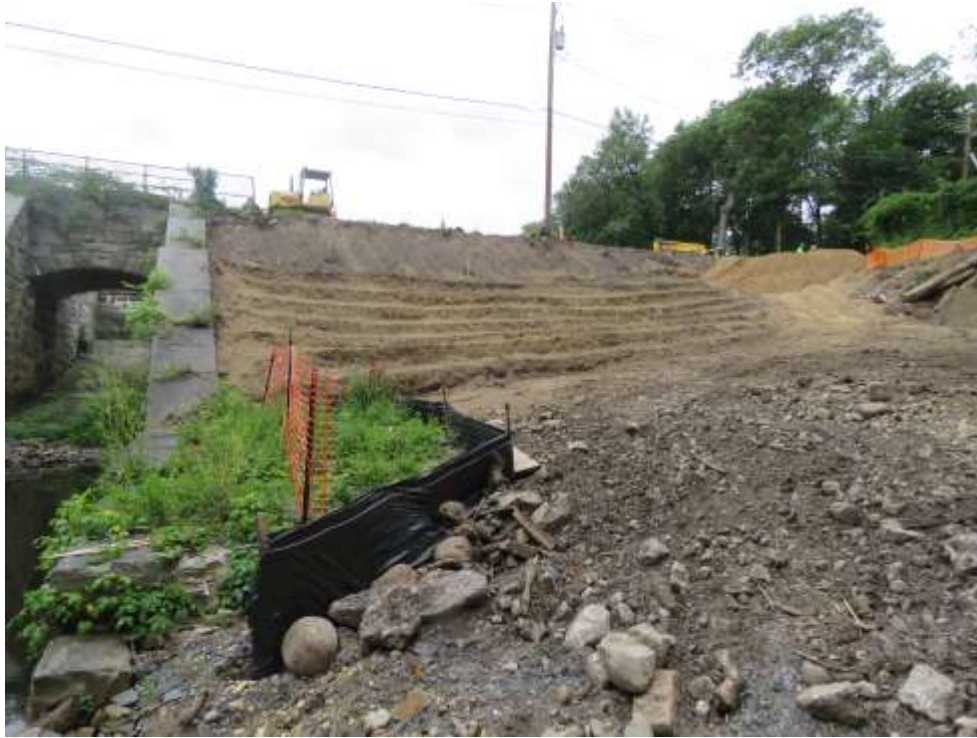
1

Left Side of Downstream Embankment Slope Following Clearing, Grubbing and Benching.

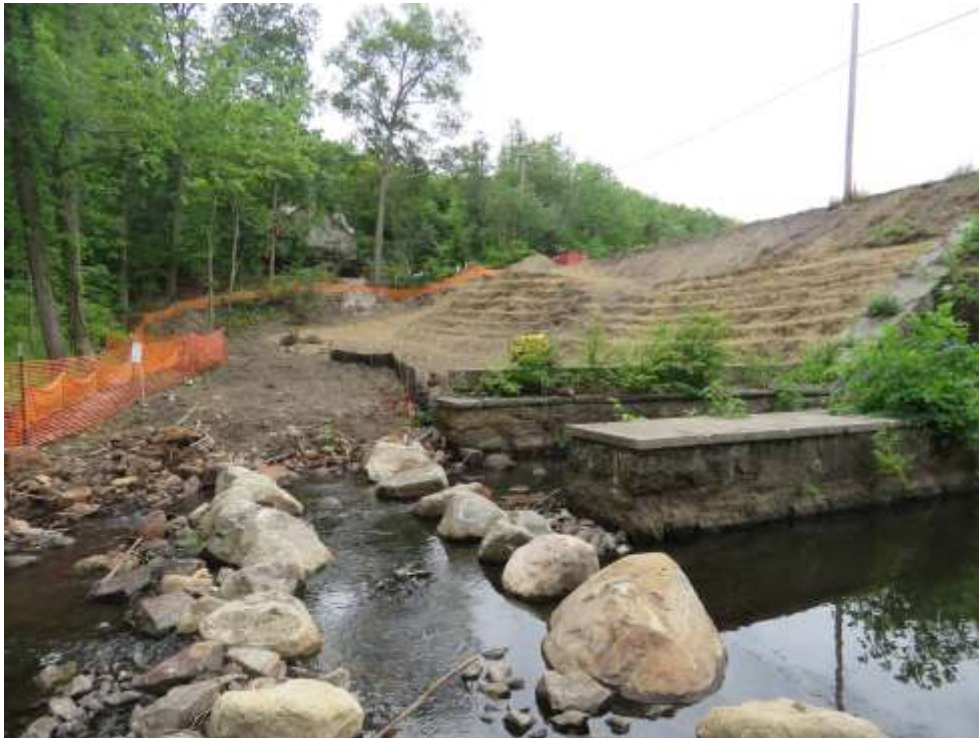
2

Right Side of Downstream Embankment Slope Following Clearing, Grubbing and Benching.

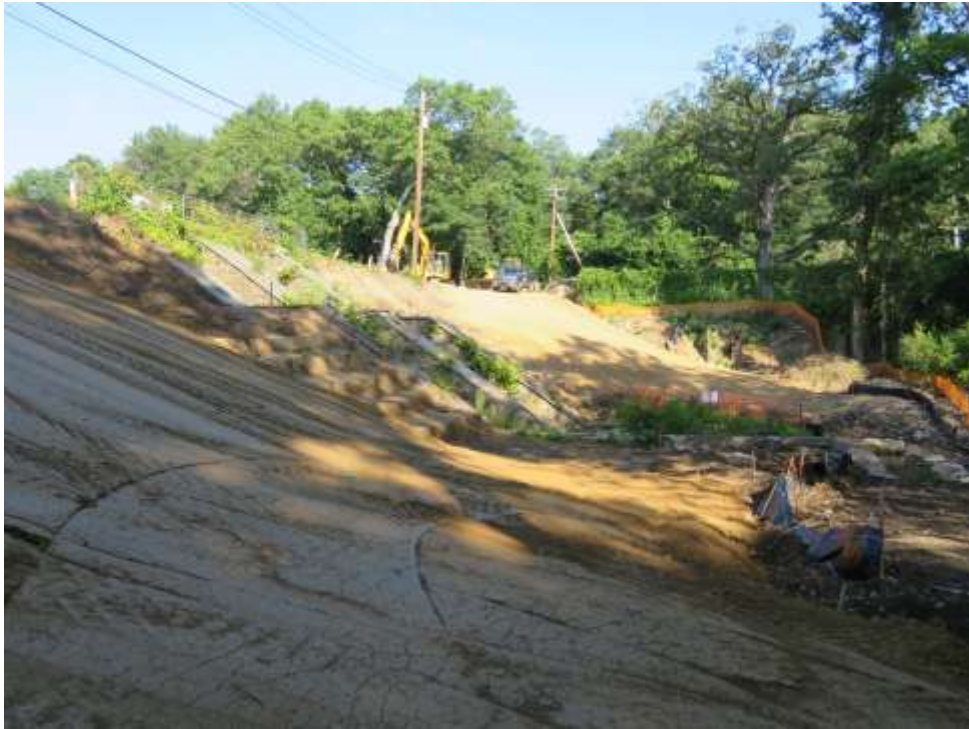
3

Compacted Embankment Filled on right Downstream Slope after Sealing with Compactor ahead of rain.

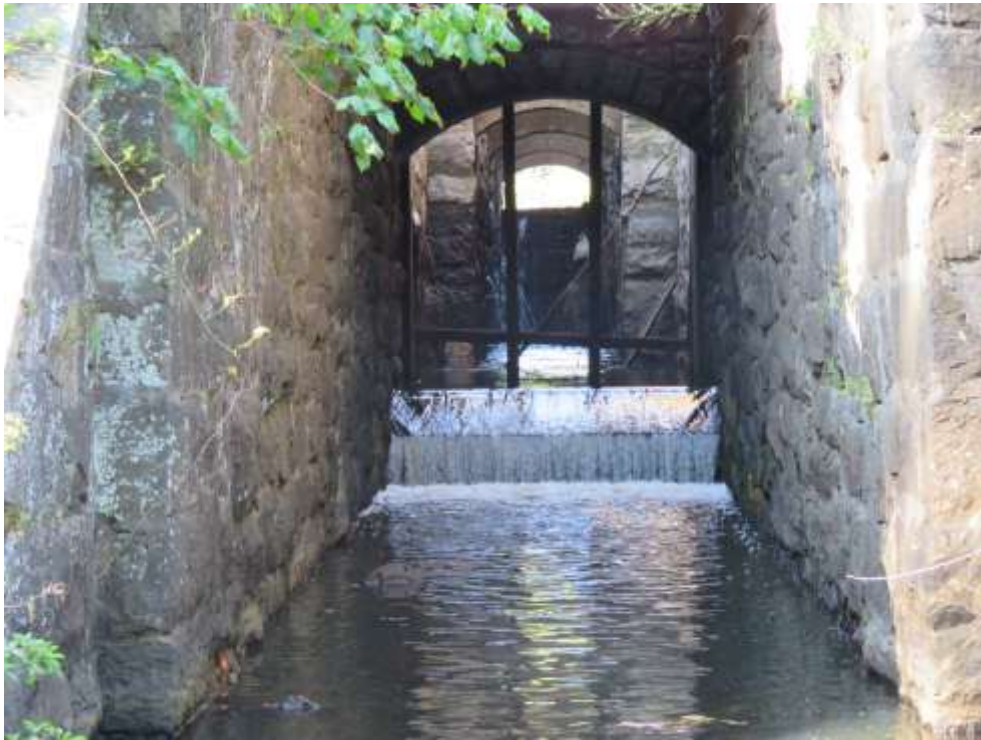
2

Looking Upstream through drained Service Spillway.

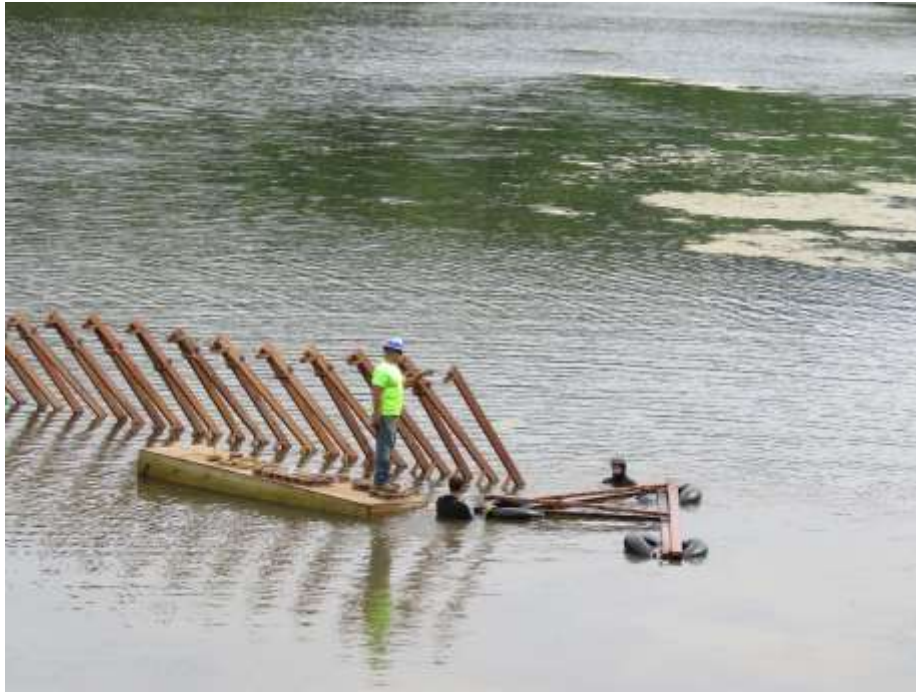
5

Contractor Assembling Temporary Cofferdam from Service Spillway to Left Abutment.

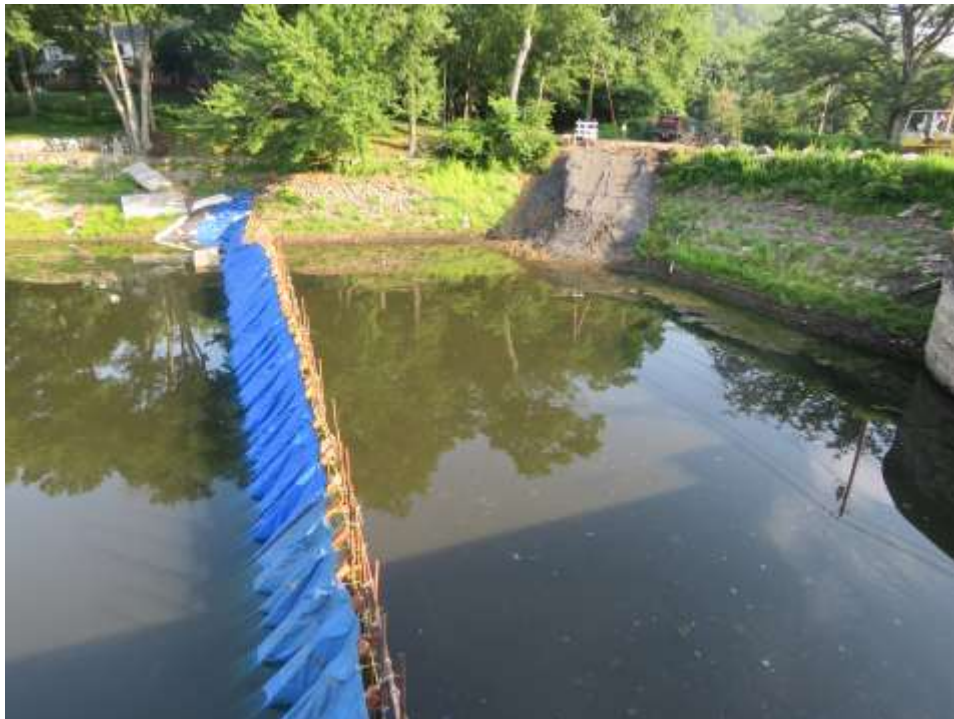
6

Completed Temporary Cofferdam and start of Dewatering of Coffered Area.

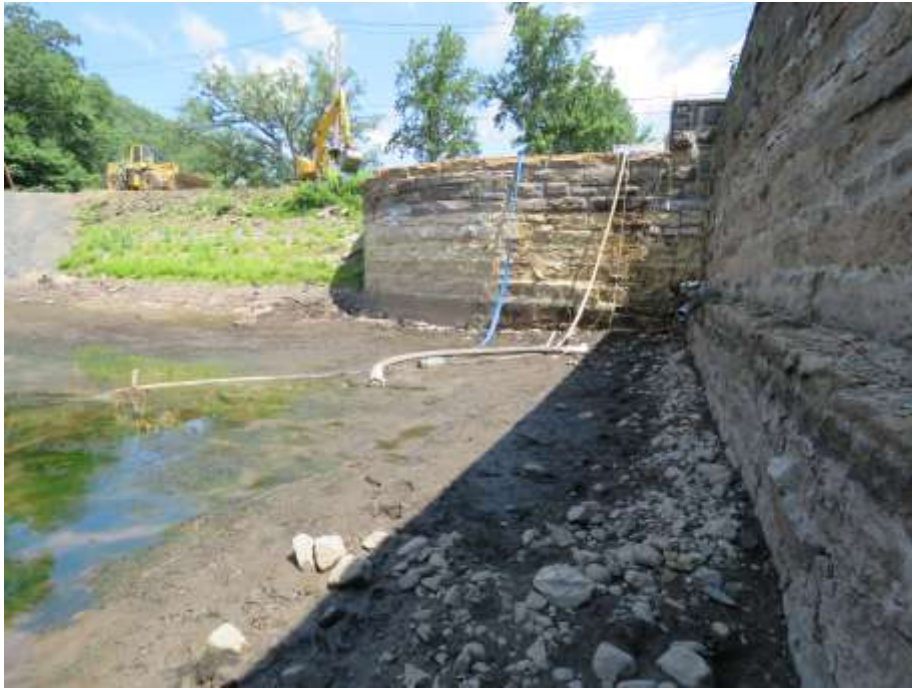
7

Dewatered Coffers Area Upstream of Auxiliary Spillway.

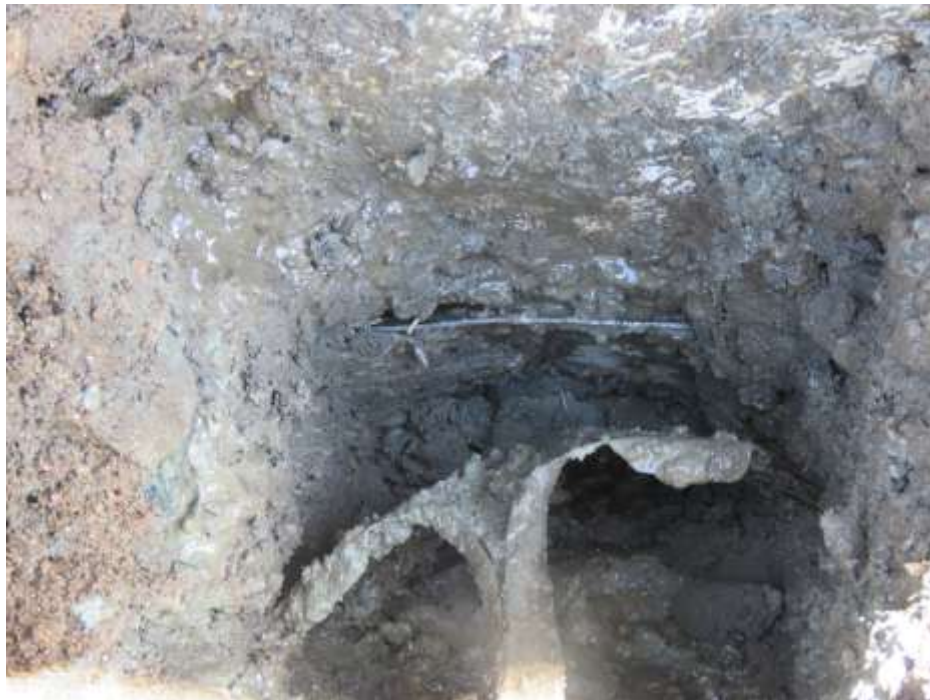
8

Existing Geomembrane (60 mil) Seepage Barrier at base of Auxiliary Spillway.

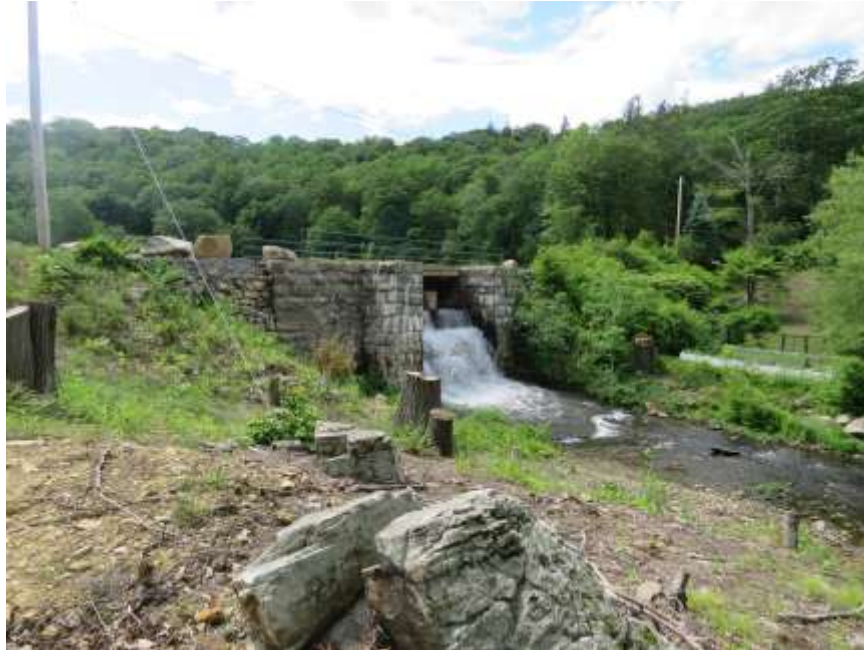
9.

View of Pond No. 3 Dam Right Abutment/Embankment Contact and Primary Spillway.

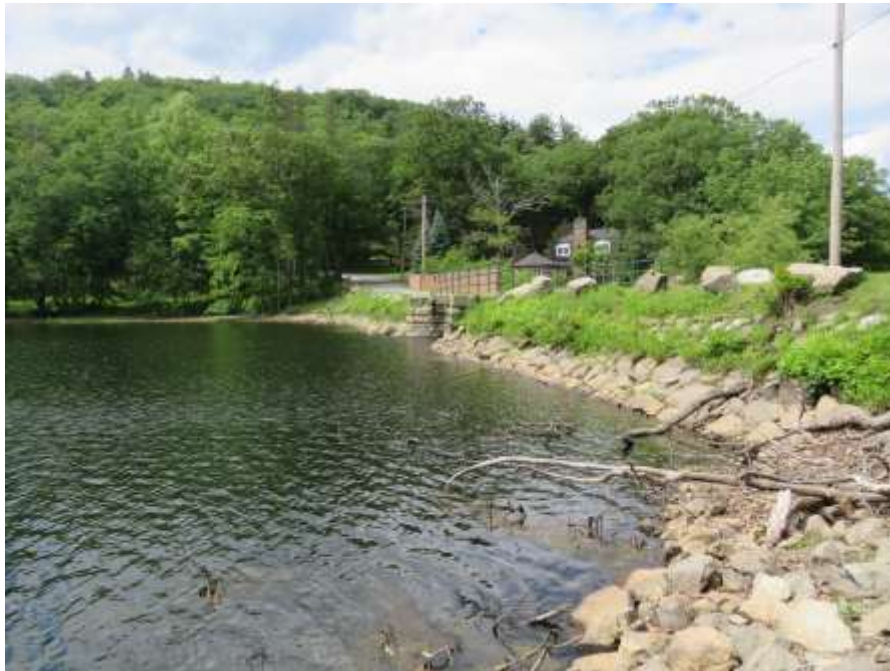
10

View of Pond No. 3 at Construction Pool. Dam Repairs and Modification Anticipated for Late Summer.
