CHA # 30855

**Wee Wah Lake & Pond No. 3
Dam Rehabilitation Project
Village of Tuxedo Park, New York**

October 26, 2017

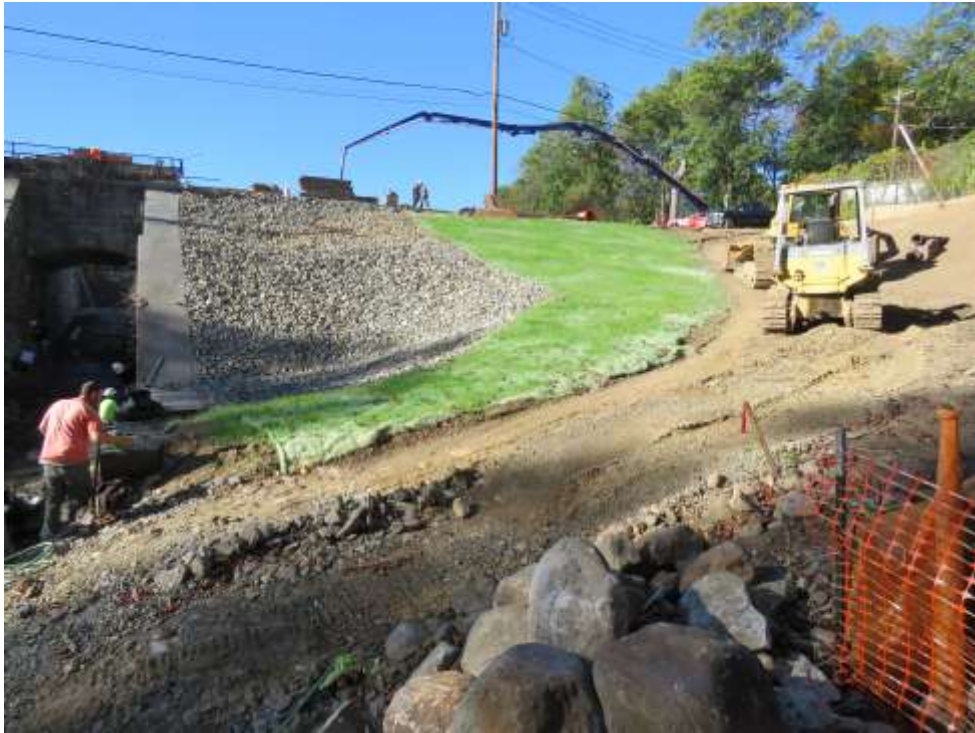
1

Left Side of Downstream Embankment Slope Showing completed rip rap and earth embankment. Permanent Access Road is not complete.

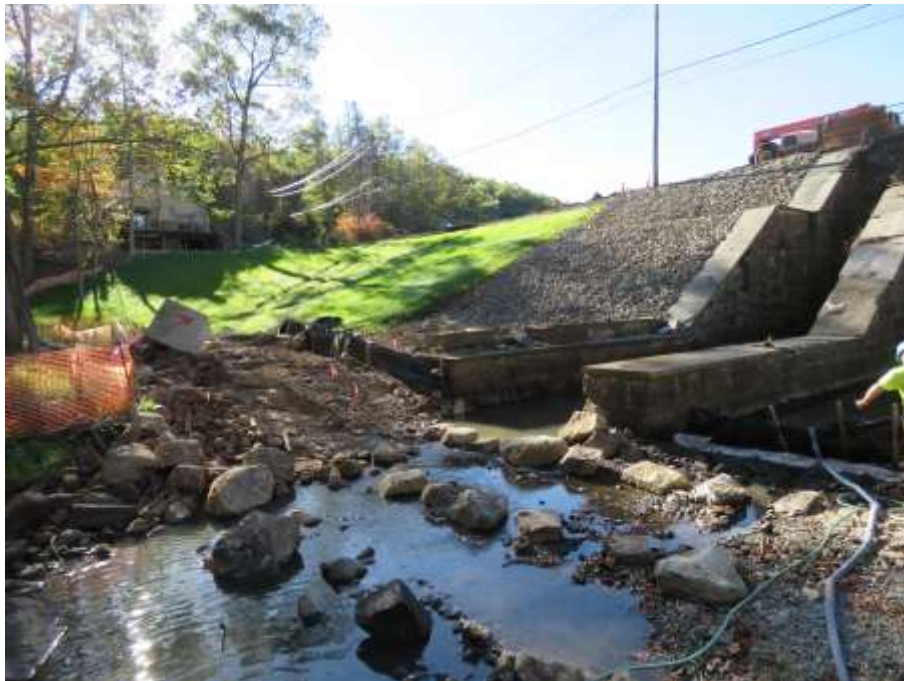
2

Right Side of Downstream Embankment Slope showing completed rip rap and earth embankment. Seepage collection and monitoring system is not complete along service discharge channel.

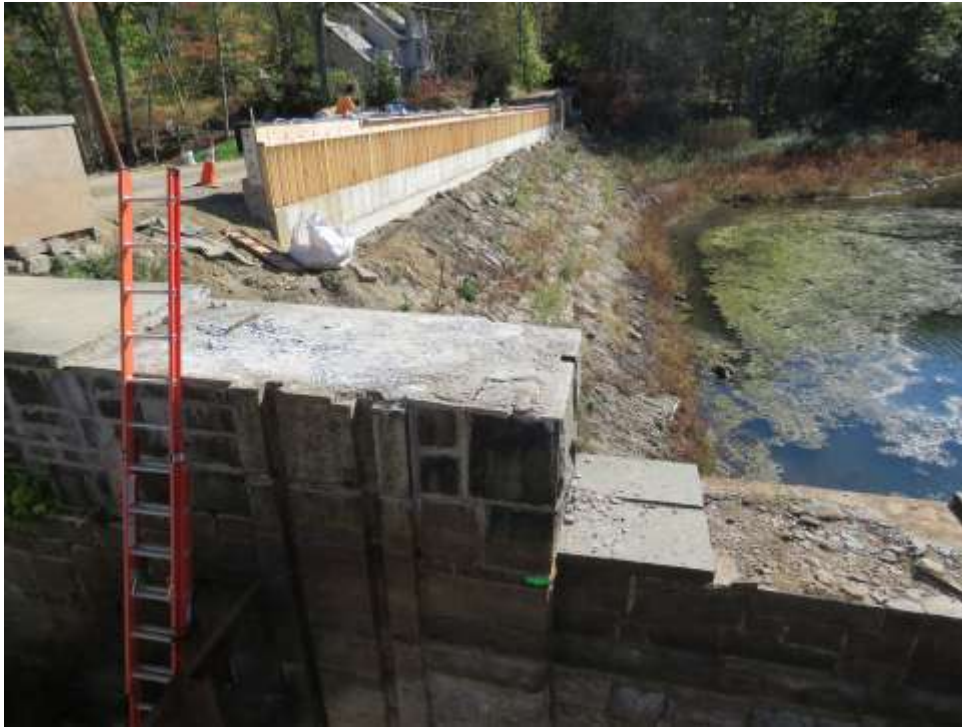
3

Capstone removal in preparation of right service spillway training wall removals for primary spillway expansion.

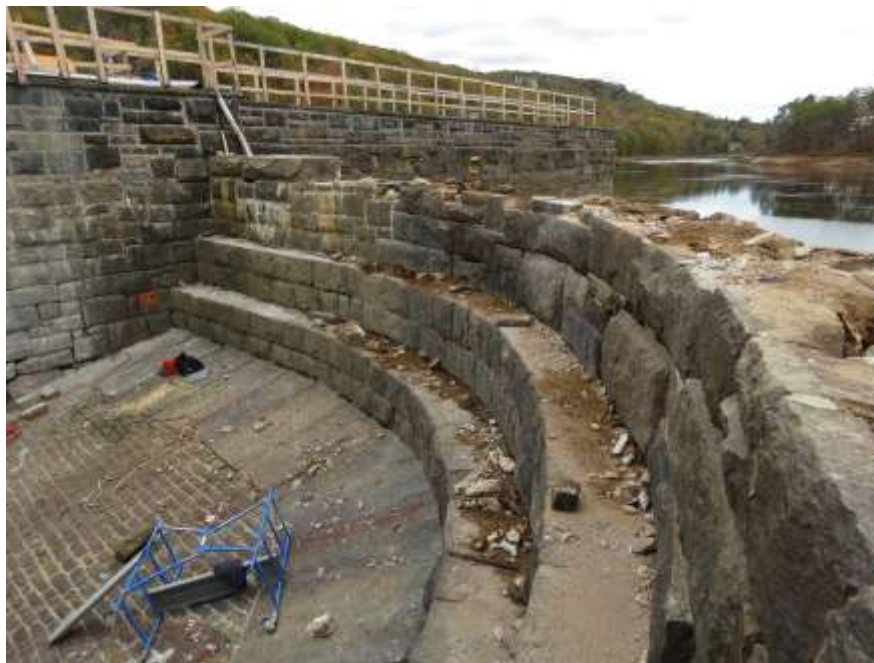
4

Capstone removal in preparation of auxiliary spillway crest reconstruction.

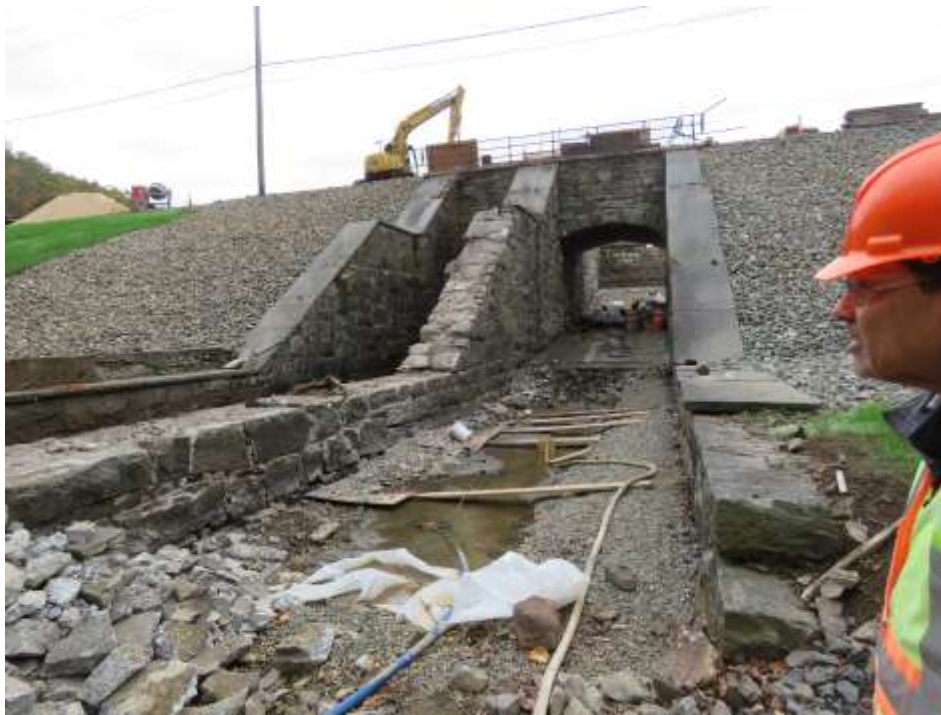
5

Remove of old concrete “capstone” for installation of new bluestone.

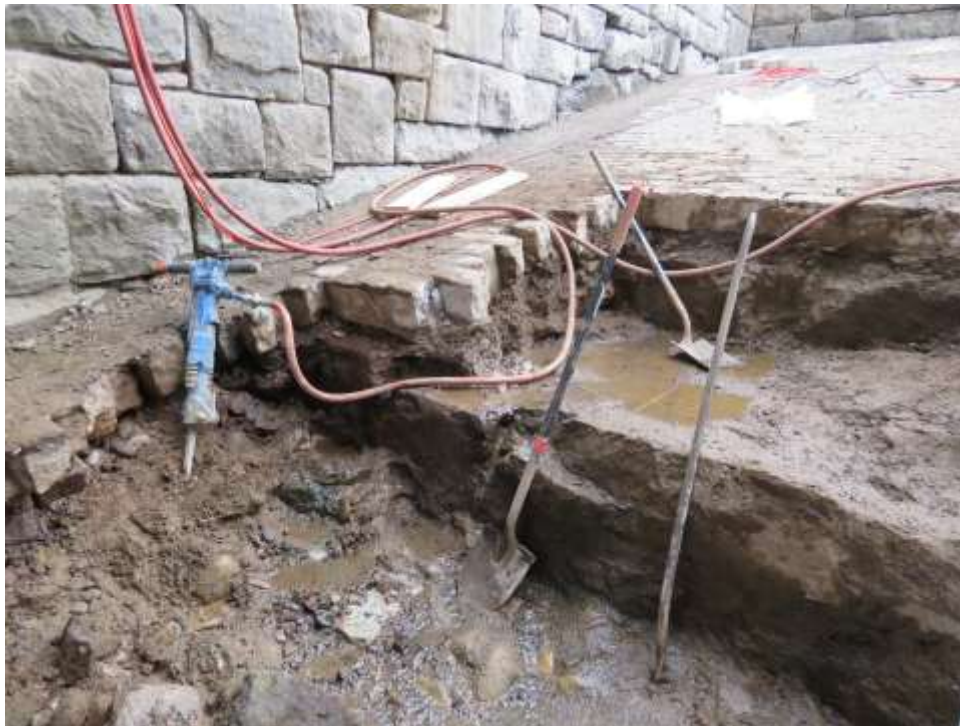
6

Excavation for repair auxiliary spillway floor.

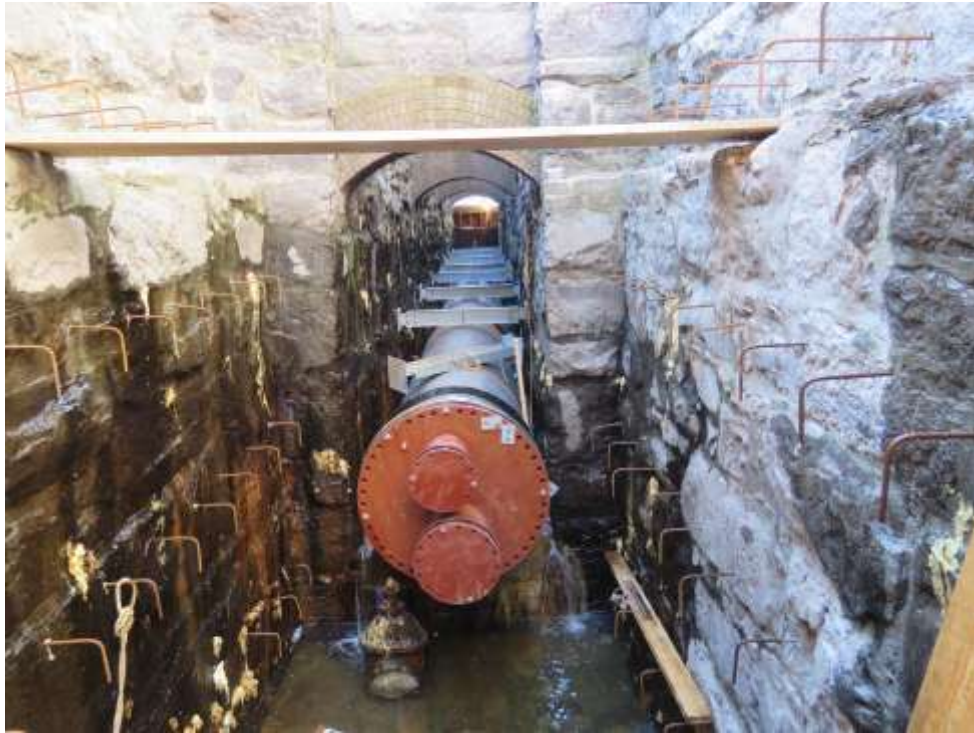
7

New low level outlet pipe set and braced in service spillway.

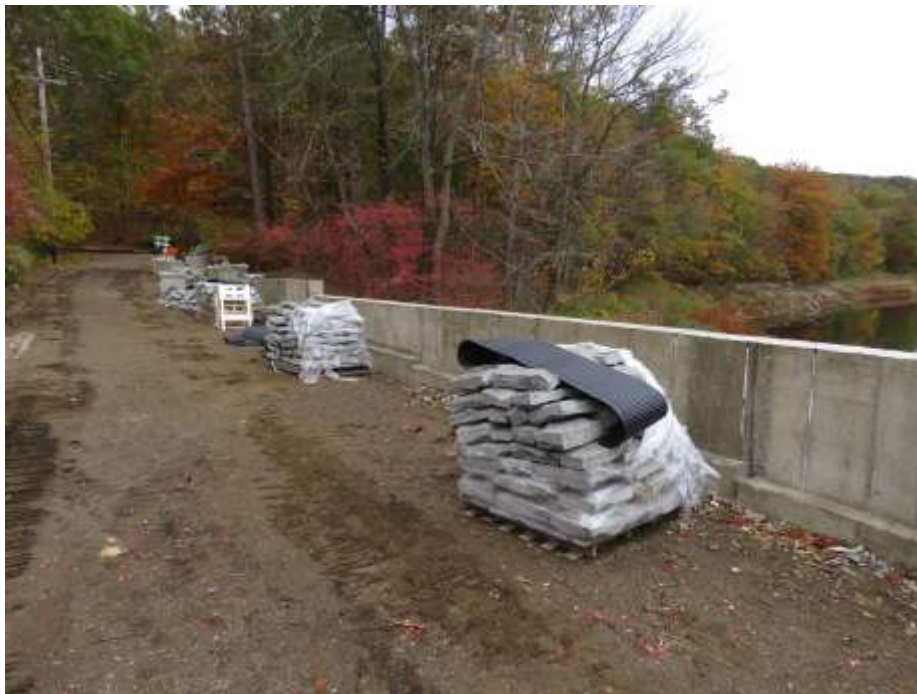
8

Completed reinforced concrete Segments E and D of Parapet Wall ready for stone effacement construction

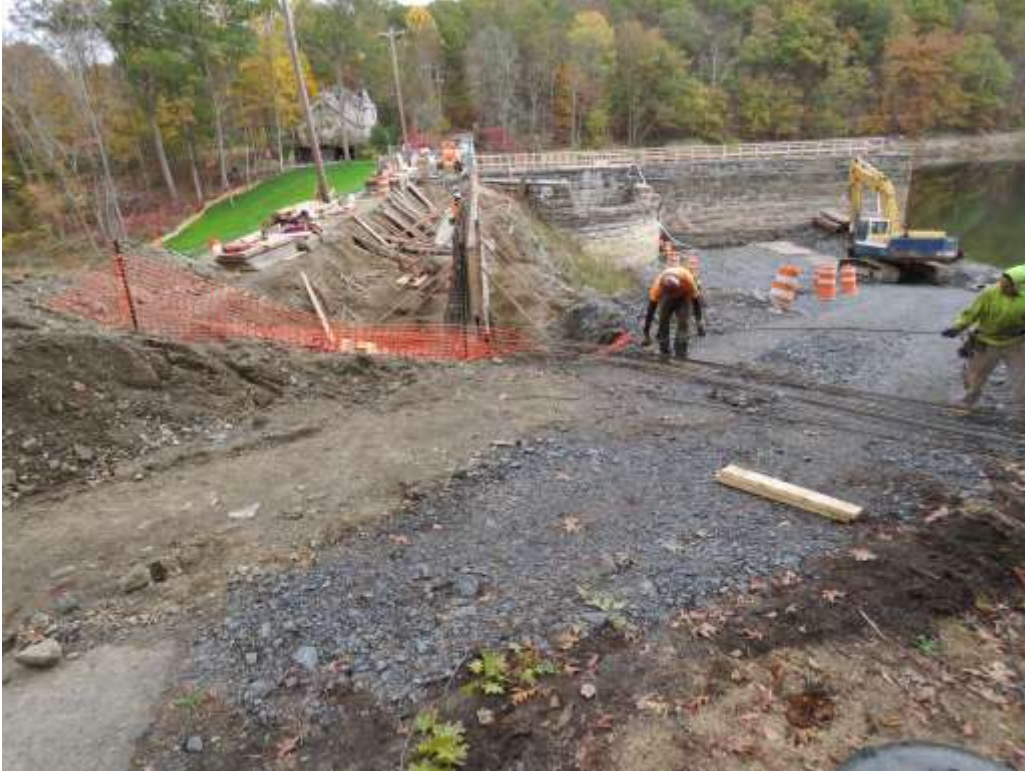
9.

Reinforced concrete construction for Segment B of Parapet Wall.

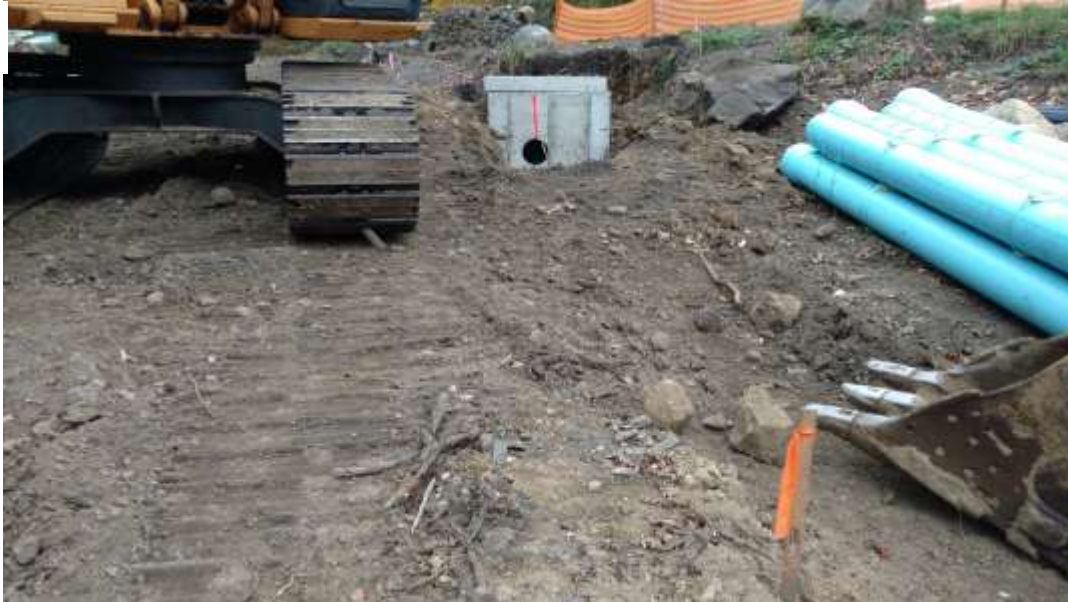
10

View of Pond No. 3 start of LLO siphon system construction. Photo shows valve vault set to grade near dam crest.
