**RE: Wee Wah Lake Dam & Pond No. 3 Dam
Project Construction Status – July 2017
Village of Tuxedo Park, New York
CHA File No.: 30855**

**Wee Wah Lake & Pond No. 3
Dam Rehabilitation Project
Village of Tuxedo Park, New York**

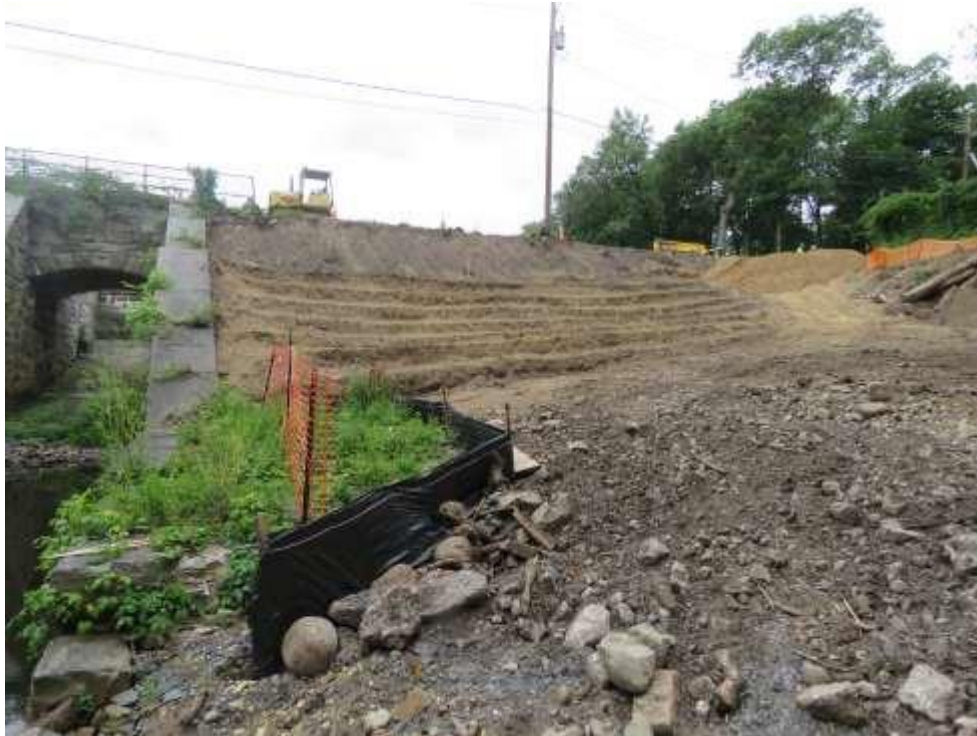
Left Side of Downstream Embankment Slope Following Clearing, Grubbing and Benching.

- clearing, grubbing and benching of the downstream embankment slope (Photo 1 and 2)
- the start of dam embankment fill placement and compaction (Photo 3) to reduce the grade of the embankment to 3H:1V
- removal of downstream stop logs and draining of service spillway (Photo 4). Water within service spillway is now at approximately elevation 472 ft. which is the crest of the end sill at the terminus of the service spillway
- installation of temporary cofferdam and dewatering in front of auxiliary spillway (Photos 5, 6, and 7)
- field investigation of reported seepage barrier found that a 60 mil HDPE geomembrane is present at the base of the auxiliary spillway weir structure. This membrane will be replaced by the reinforced concrete overpour wall and sheet pile cutoff wall (Photo 8)

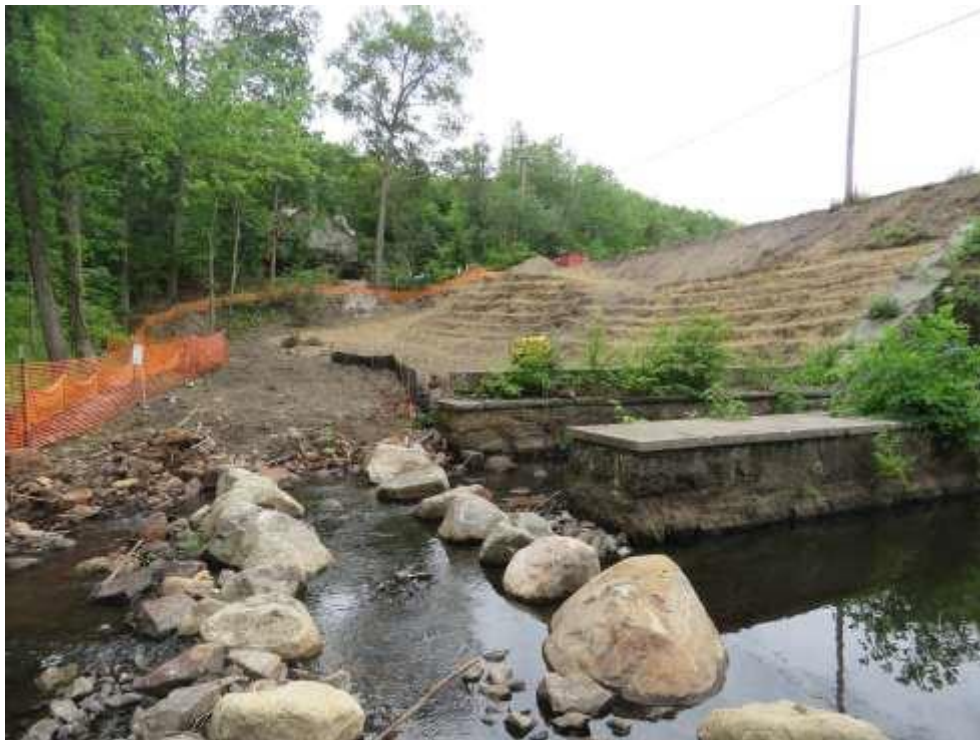
2

Right Side of Downstream Embankment Slope Following Clearing, Grubbing and Benching.

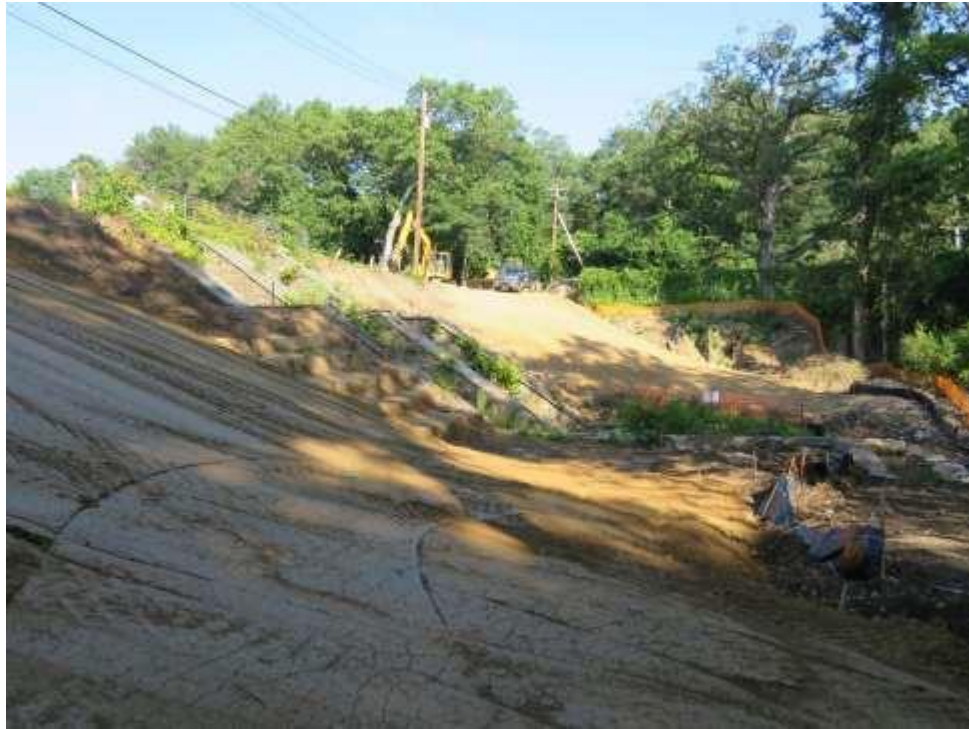
3

Compacted Embankment Filled on right Downstream Slope after Sealing with Compactor ahead of rain.

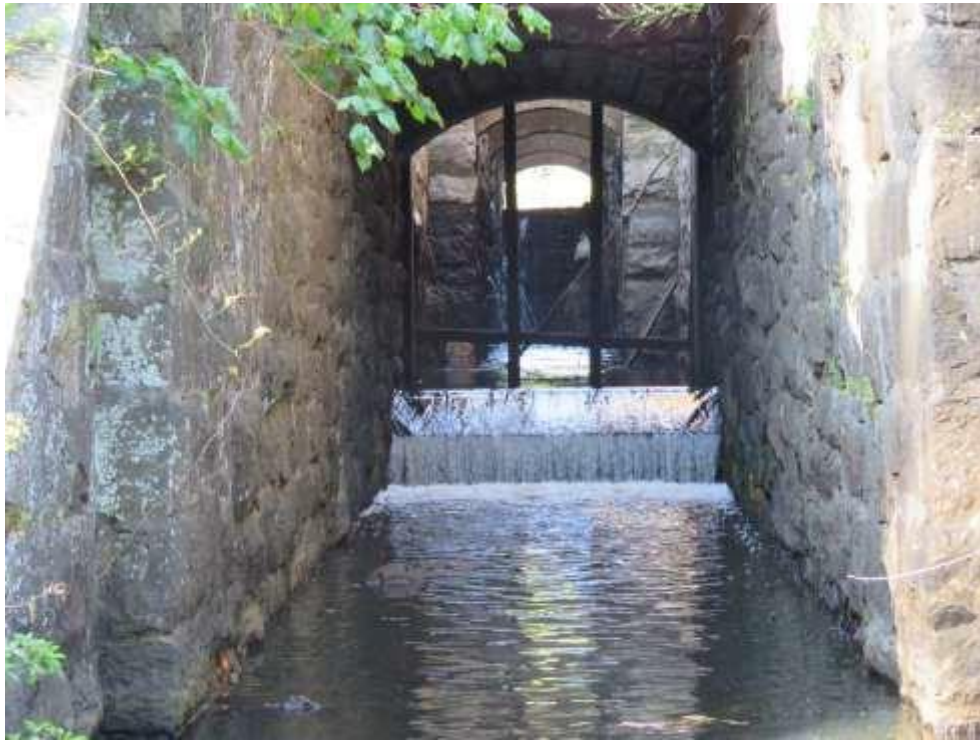
2

Looking Upstream through drained Service Spillway.

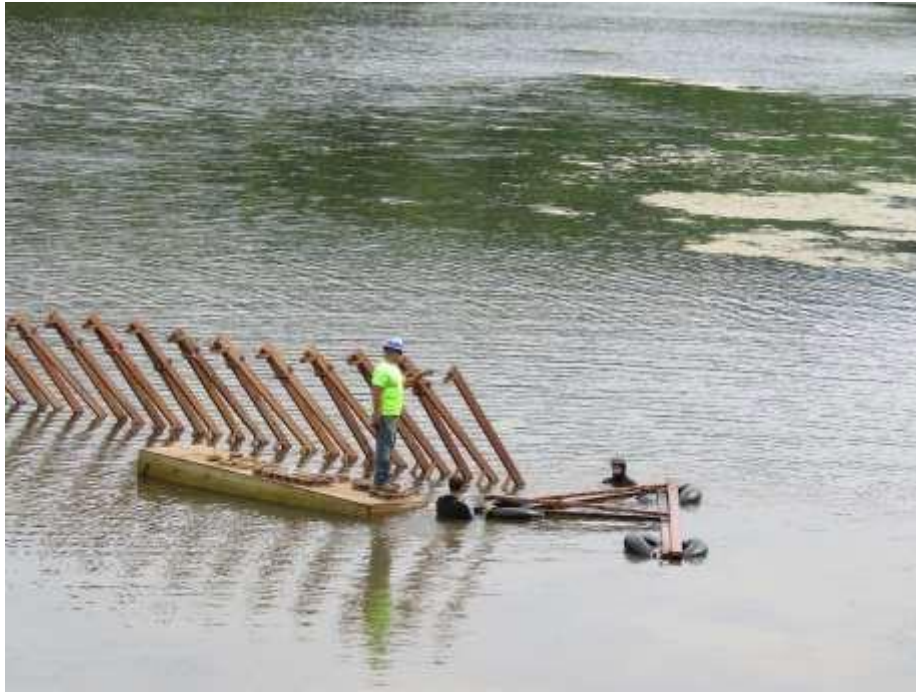
5

Contractor Assembling Temporary Cofferdam from Service Spillway to Left Abutment.

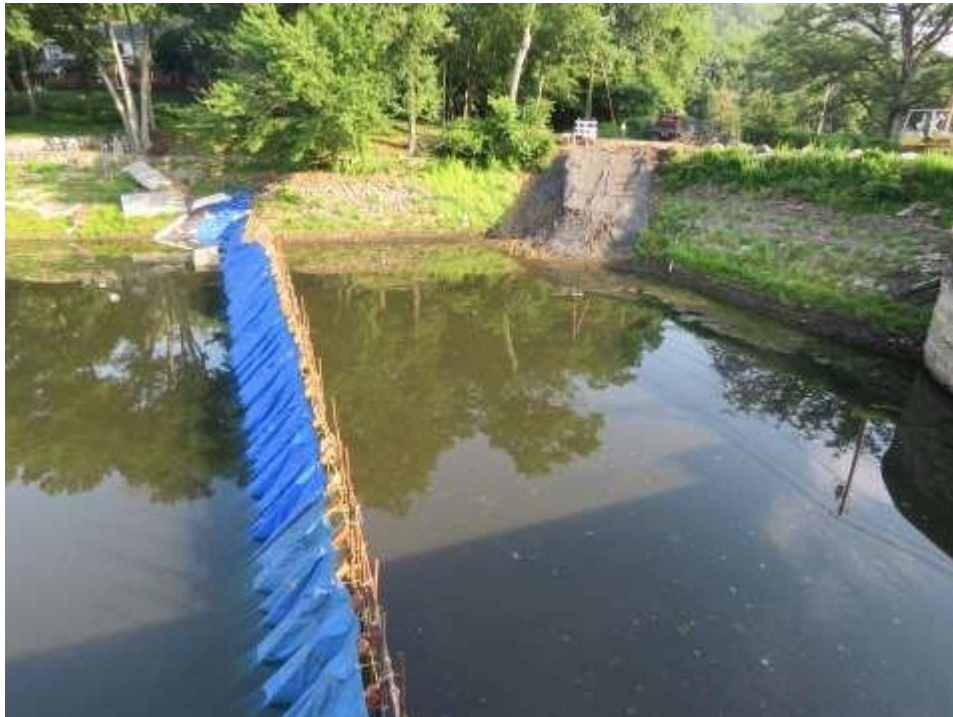
6

Completed Temporary Cofferdam and start of Dewatering of Coffered Area.

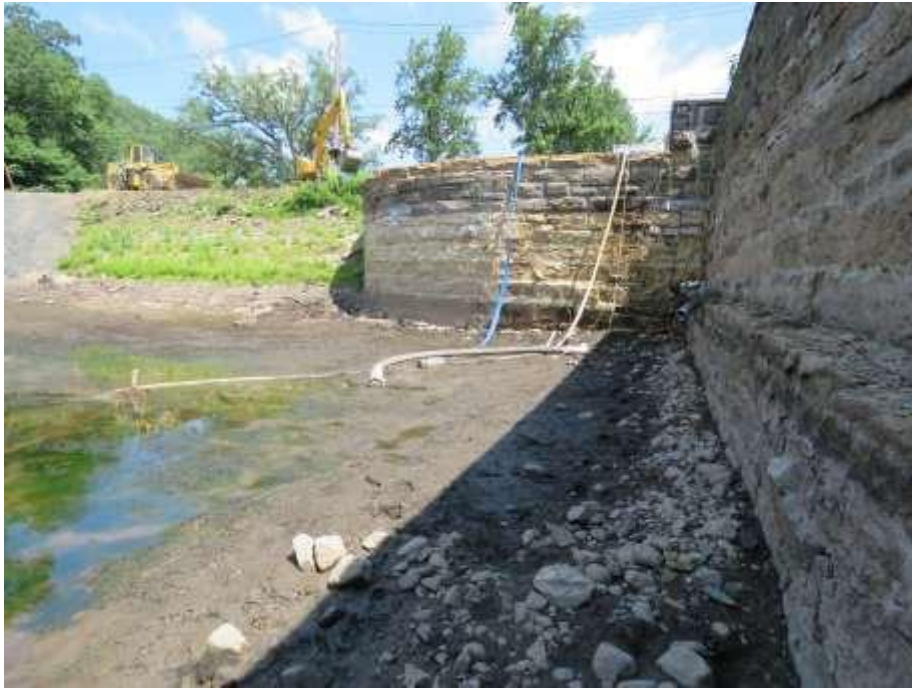
7

Dewatered Cofferd Area Upstream of Auxiliary Spillway.

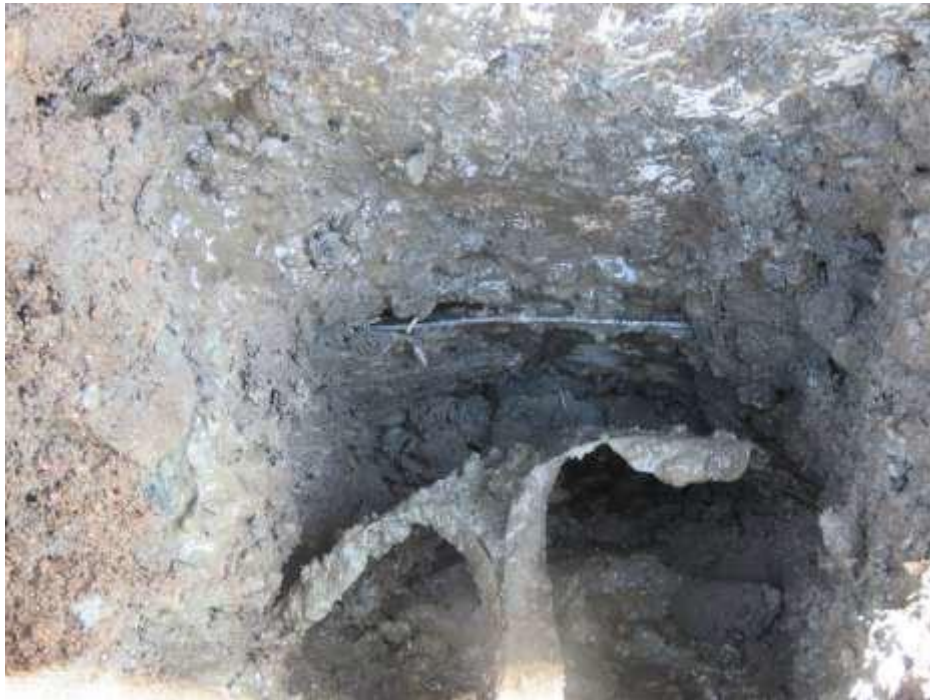
8

Existing Geomembrane (60 mil) Seepage Barrier at base of Auxiliary Spillway.

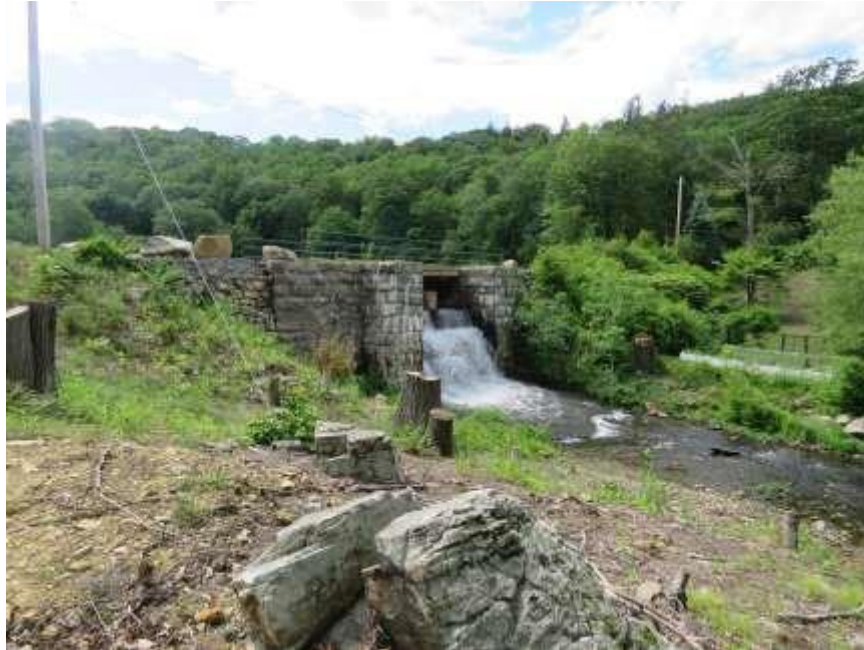
9.

View of Pond No. 3 Dam Right Abutment/Embankment Contact and Primary Spillway.

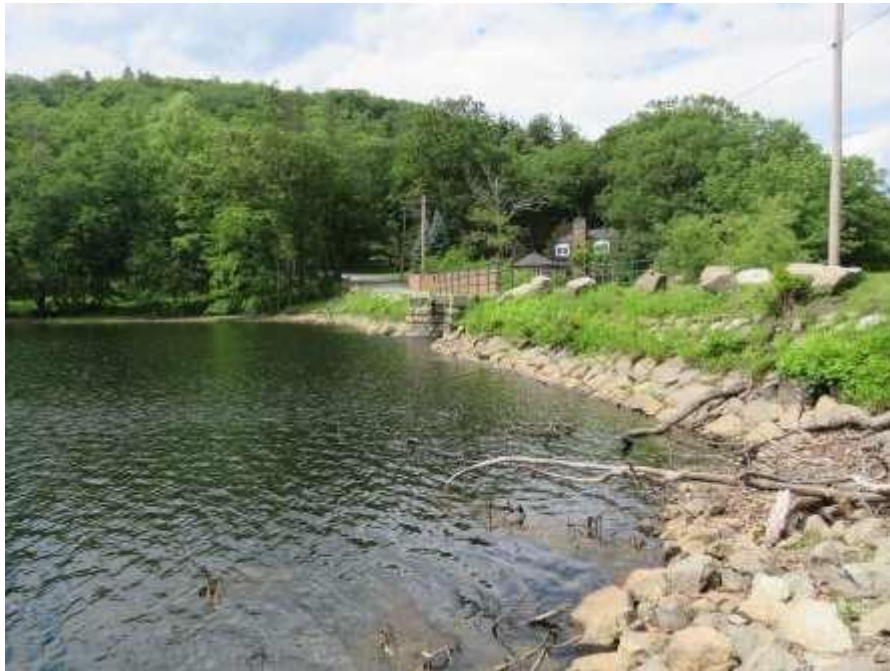
10

View of Pond No. 3 at Construction Pool. Dam Repairs and Modification Anticipated for Late Summer.
